**experience with UHV-leaks on 1500 units of
BPM-buttons at the ESRF in 2016**

***Kees Scheidt, ESRF,
ASD, diagnostics group***

contents

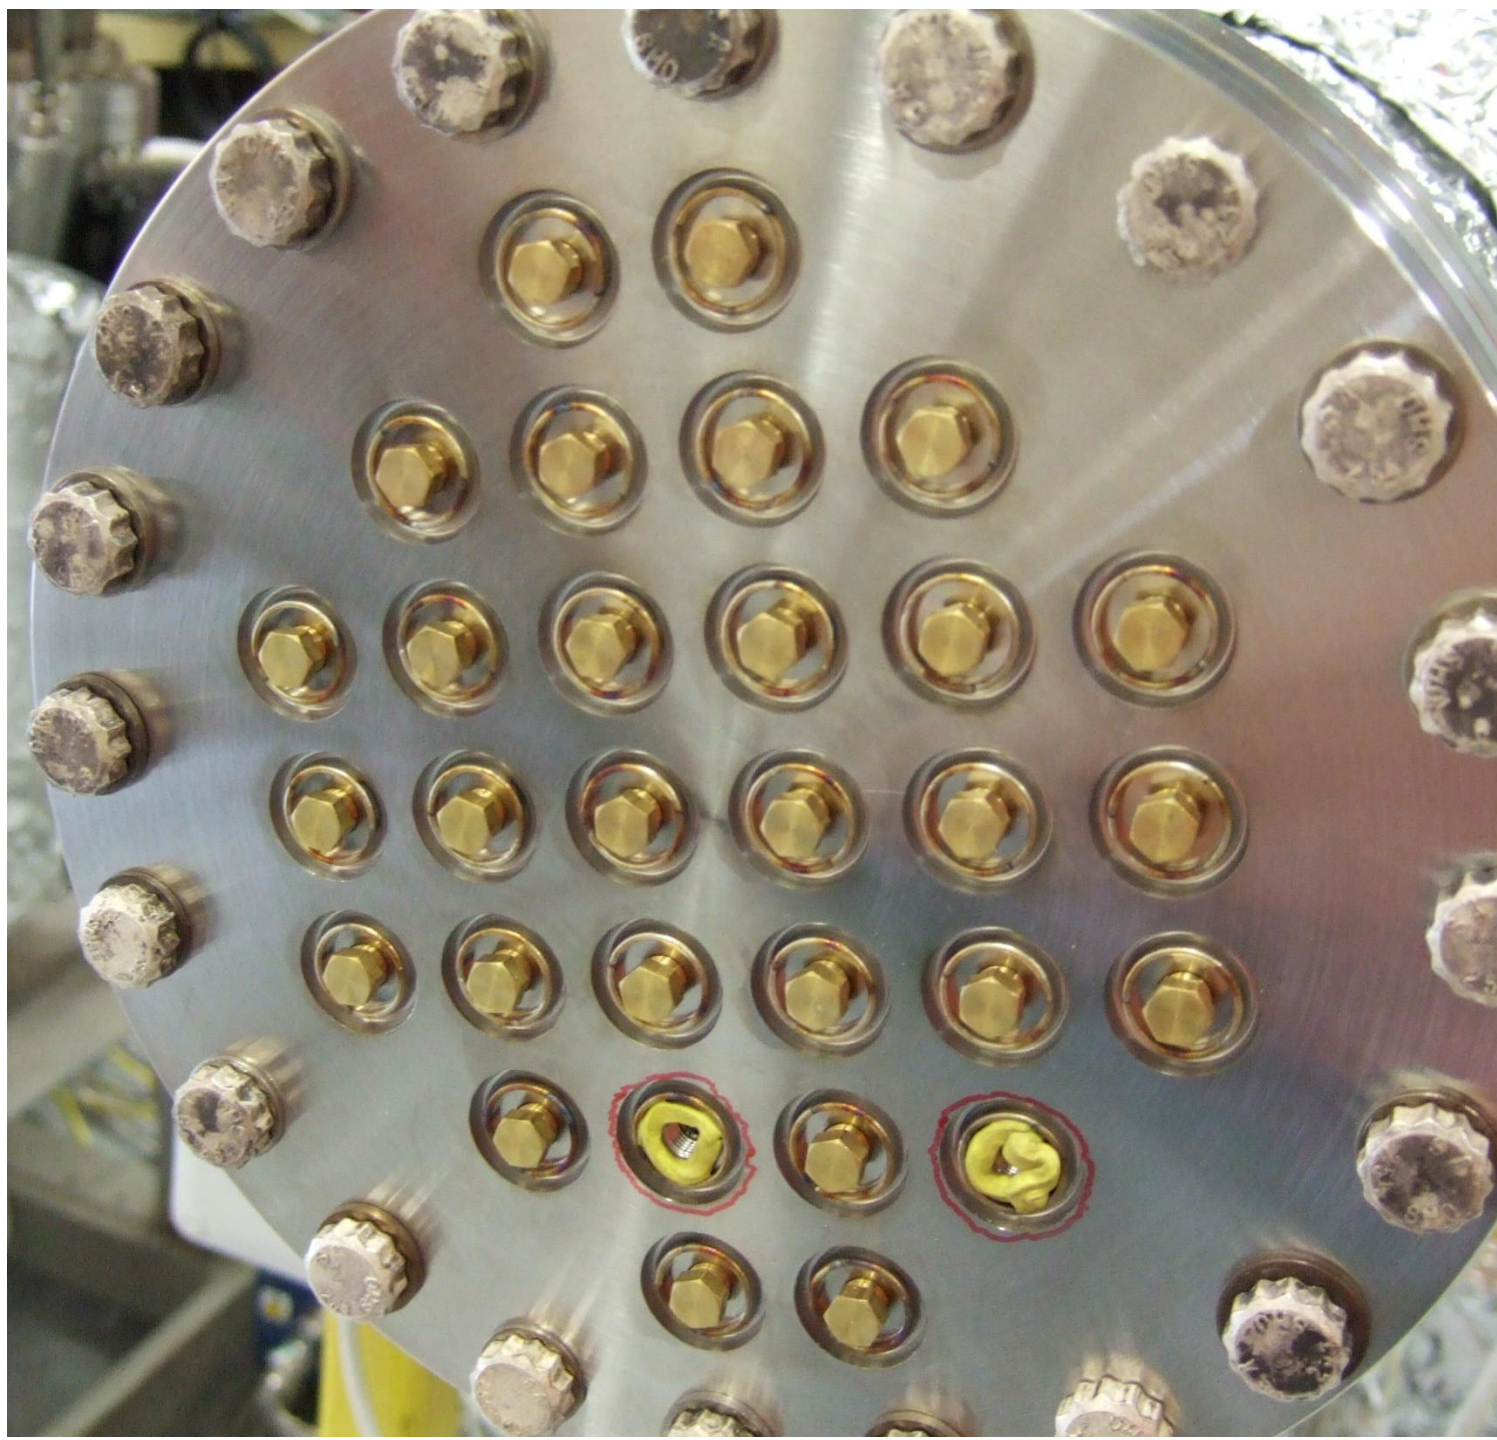
just before Christmas 2016 :
alarm from FMB : several (about 10%) units are leaking ... !

the ESRF sacrifices many units by welding 30 into a test-flange(s) and
trying to get : 1) statistics, 2) an insight of where the leak is situated ...

30 BPMs in one
CF150 flange

done 2 x
so **60 units** tested
→ **5 leaks**

the leaking spots
are confirmed to
be in the lip-corner

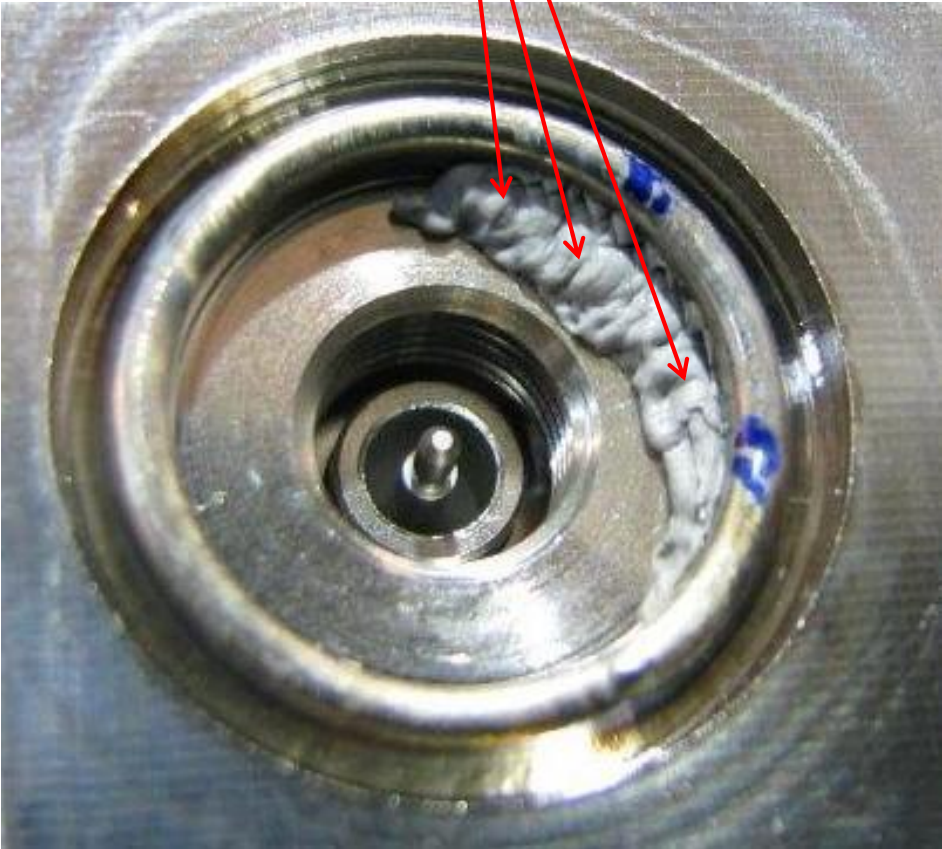
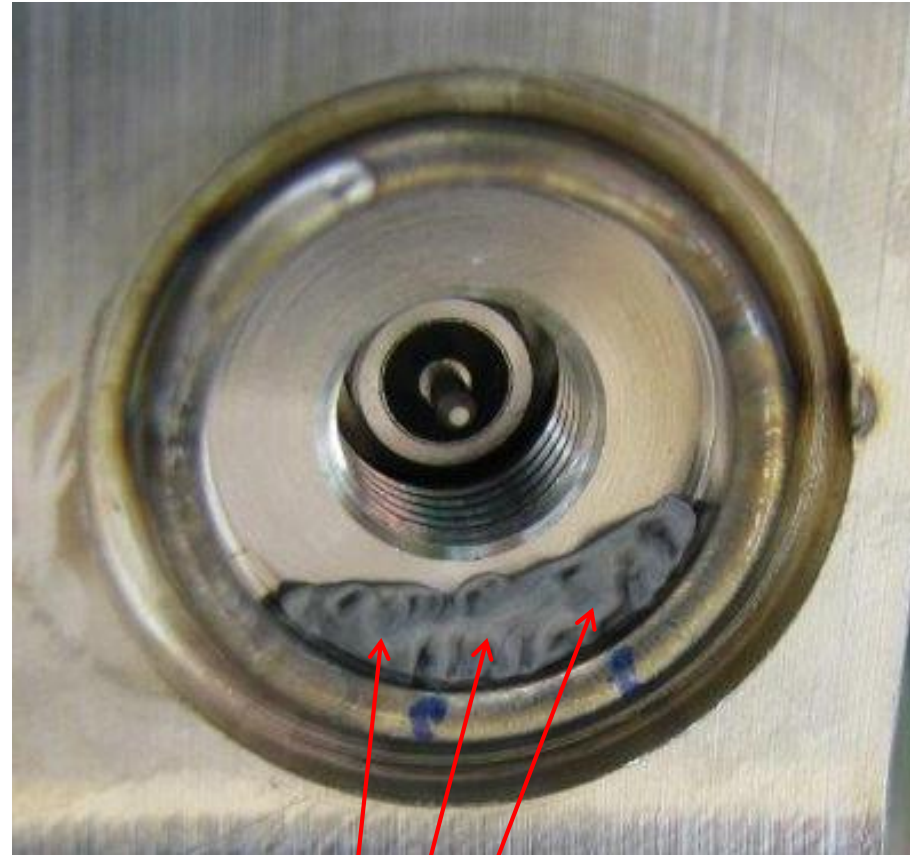
vacuum wax applied : the leak is stopped !

the vacuum wax is applied in the corner, i.e. between
the transition of the lip & the main body,
the leak (fracture) must be situated there, not on the welding

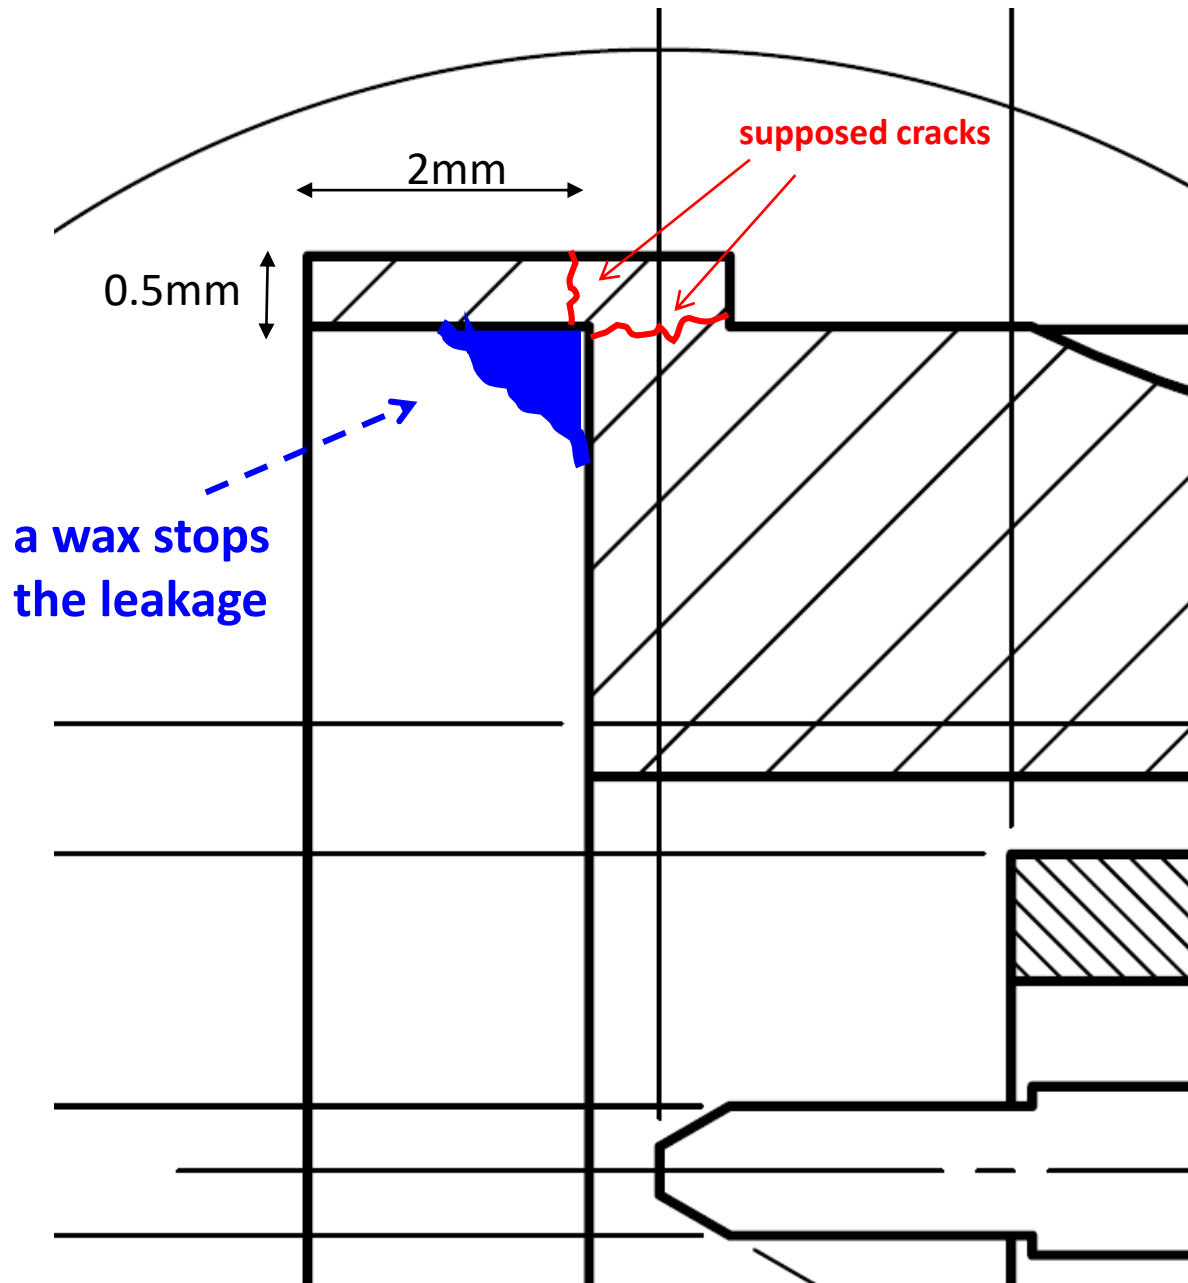
vacuum wax applied :
the leak is stopped !

FMB experience : 4 failures out of 16 buttons welded → 25% failure-rate

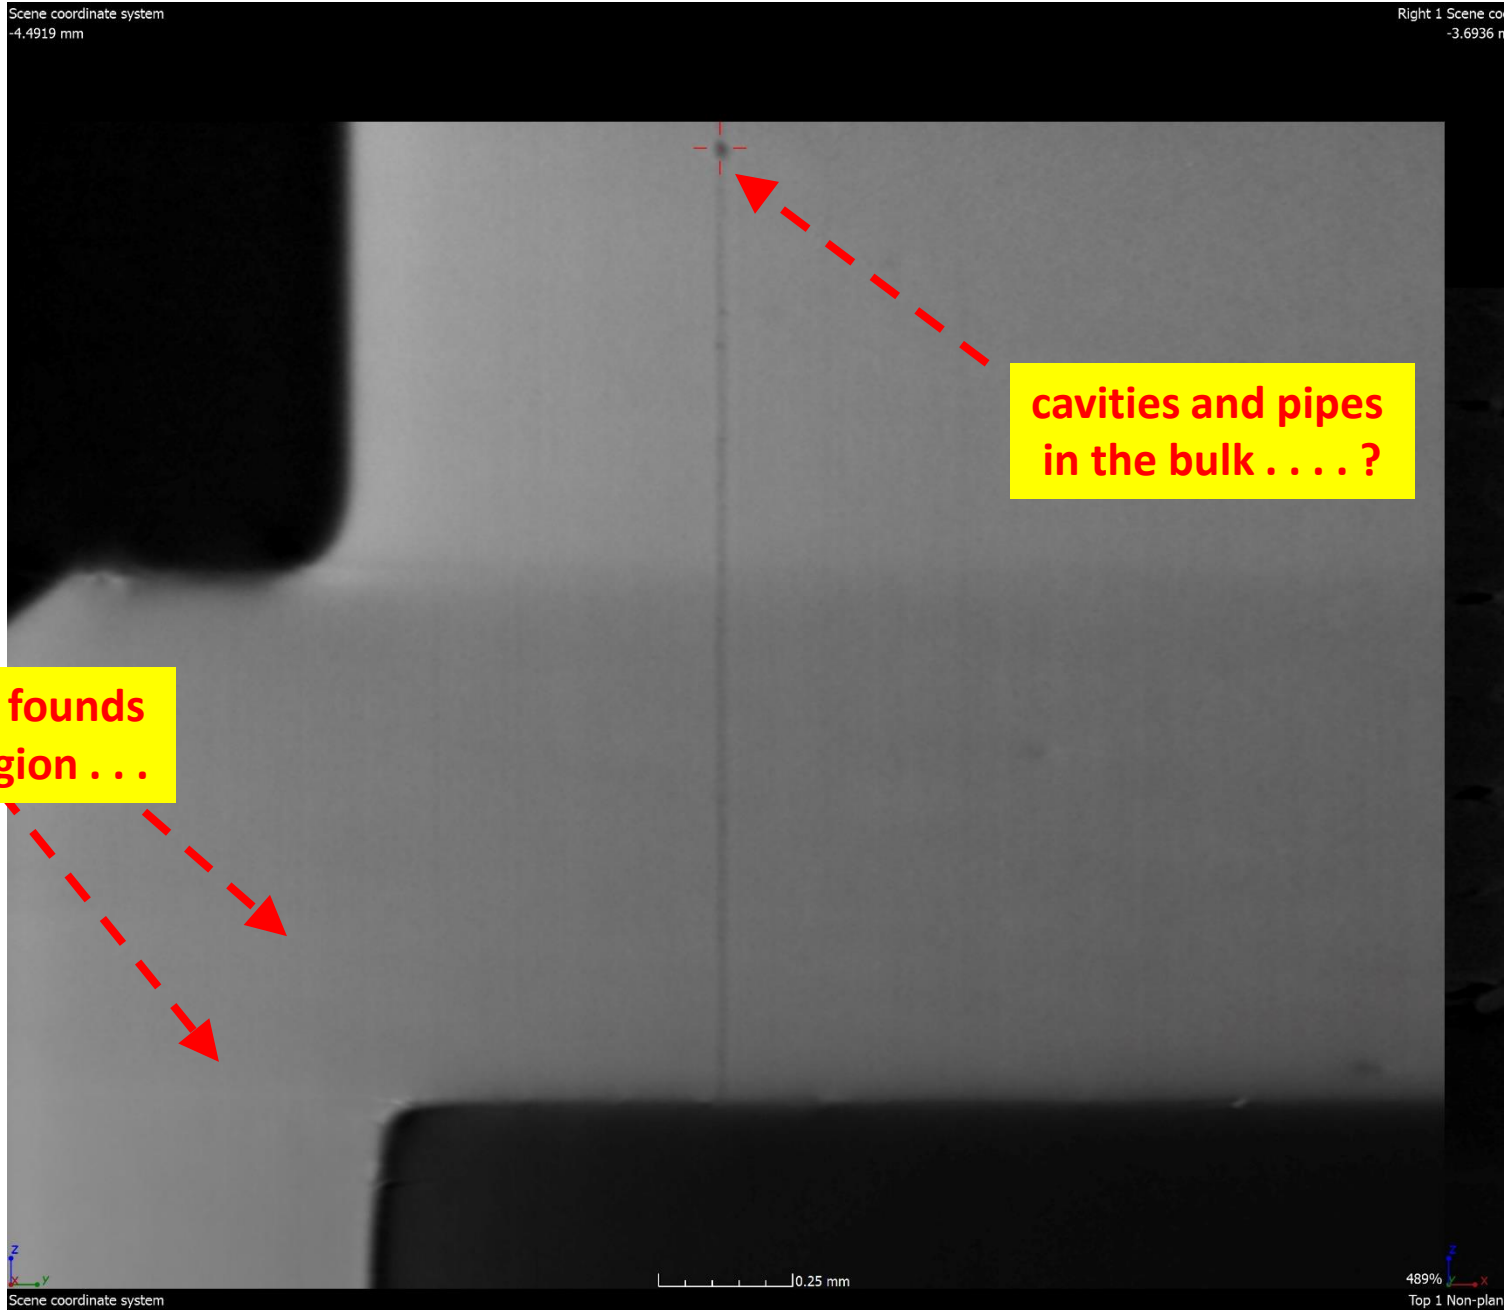
X-ray tomography done at a dedicated ESRF beamline on a leaking BPM-button :

cylinder around the ceramic

**the crack changes
angle/orientation
after the cavity**

big cavity

**the crack/pipe/channel
traverses the full depth
of the steel outer-body**

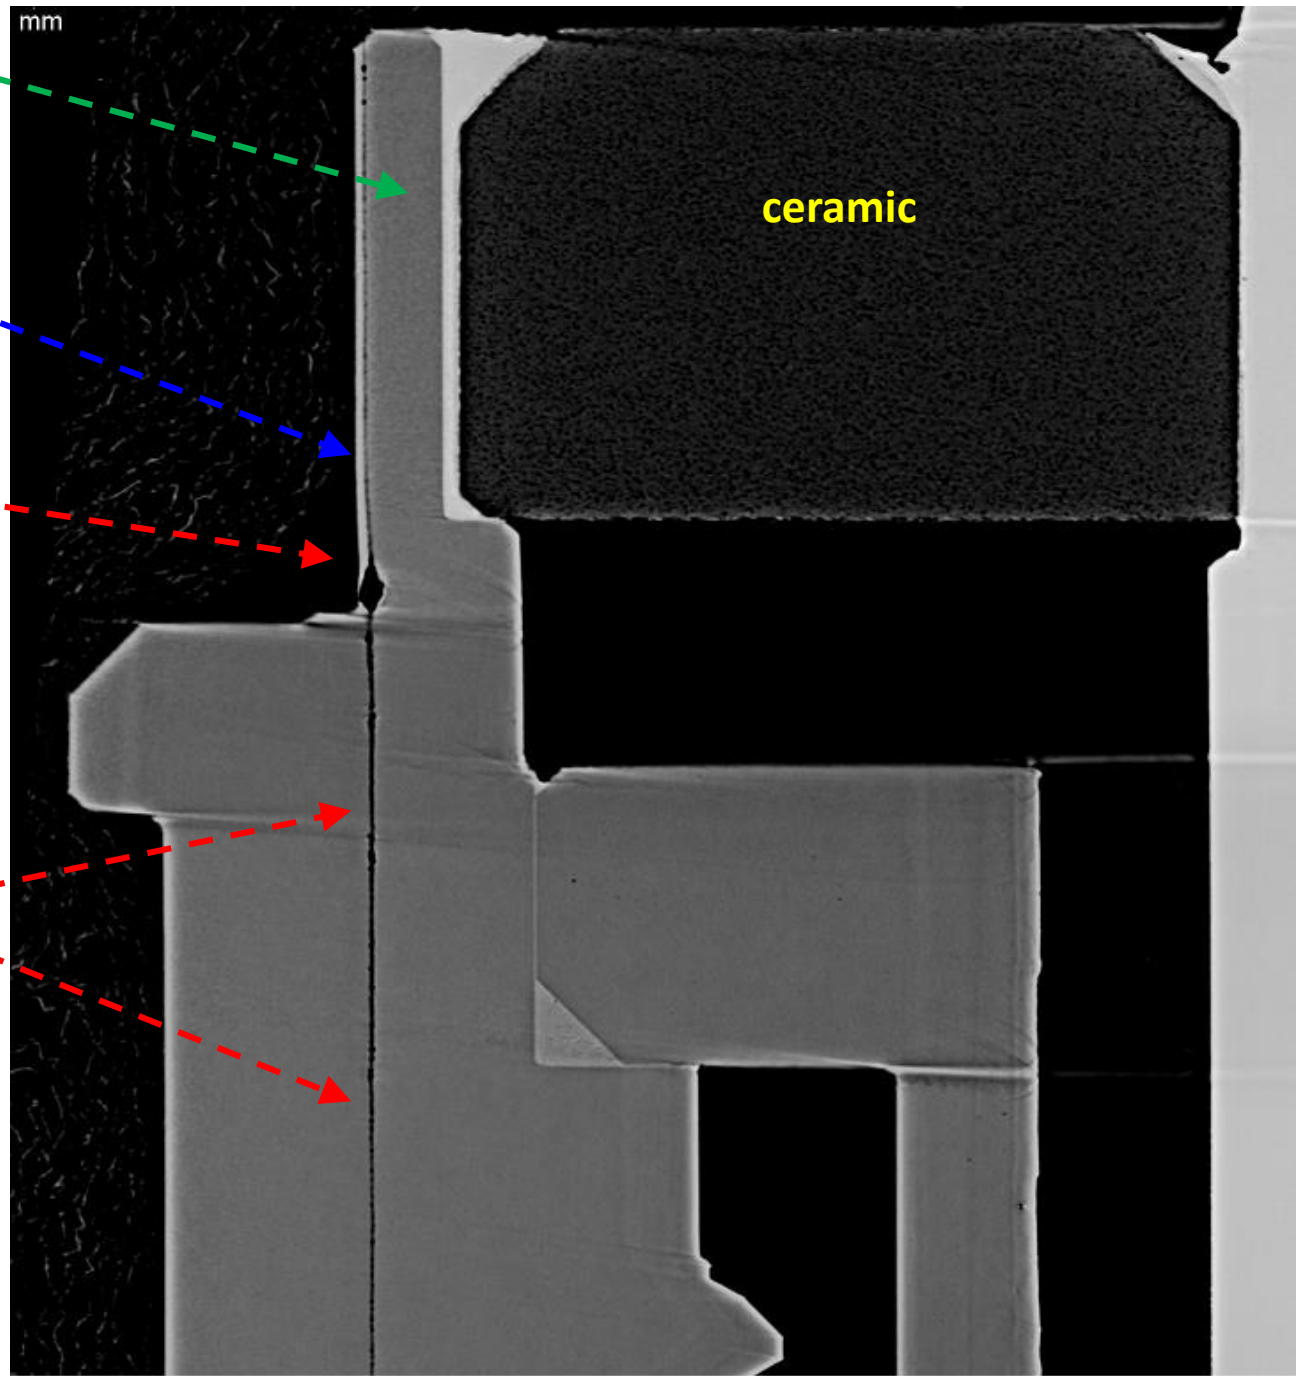
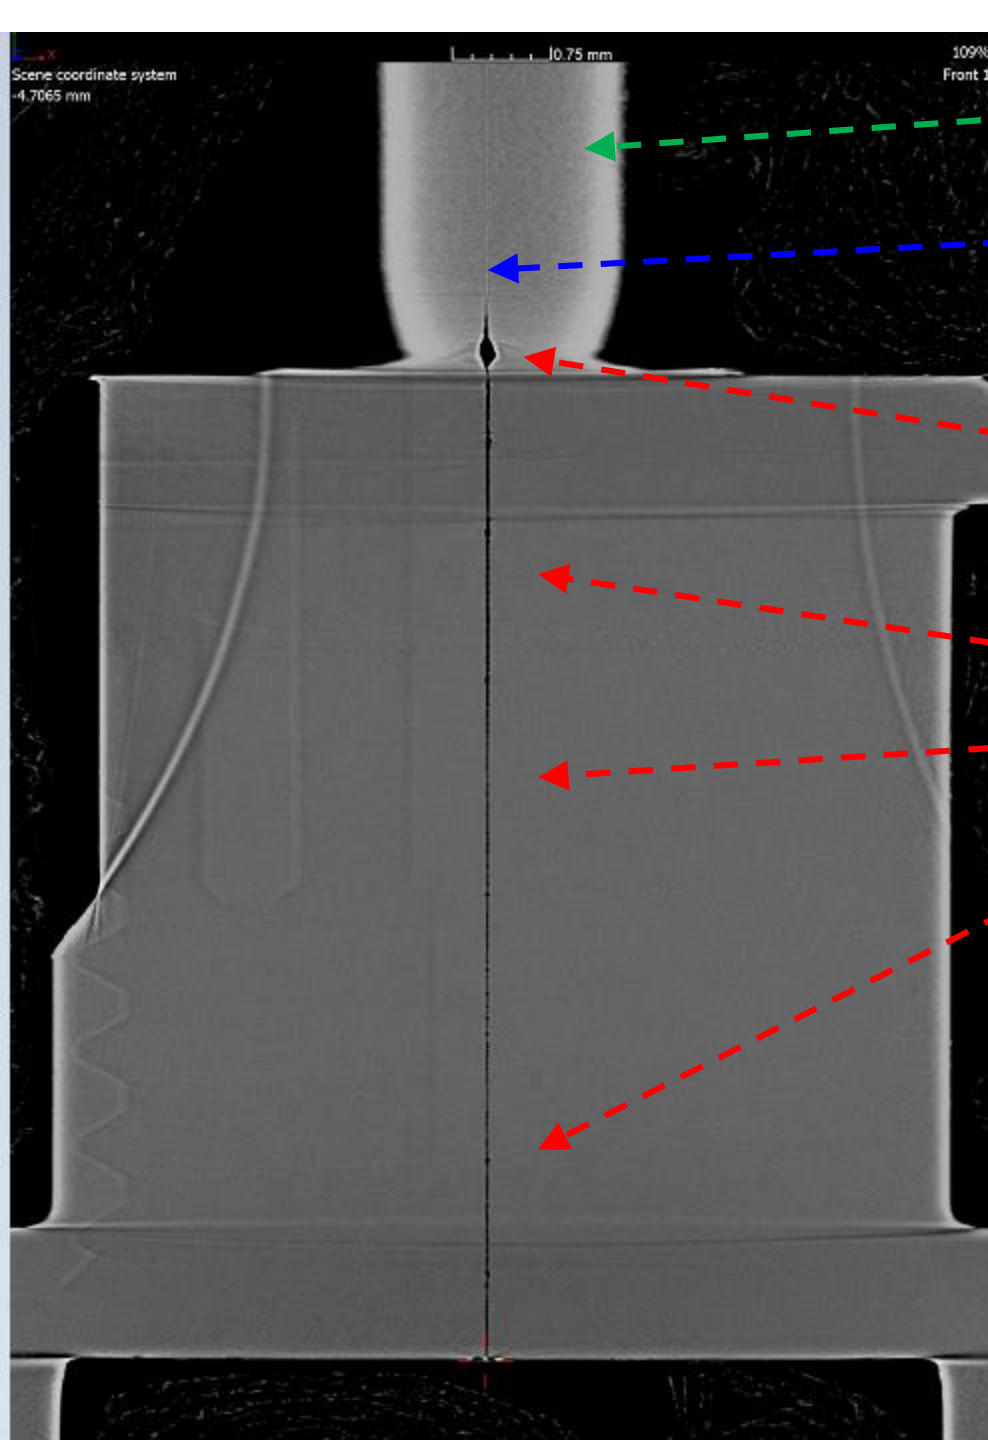
cylinder around the ceramic

**the crack is not visible, at this point, in this slice
since it changed angle/orientation
(after the cavity) see previous slide**

big cavity

**the crack/pipe/channel
traverses the full depth
of the steel outer-body
>10mm**

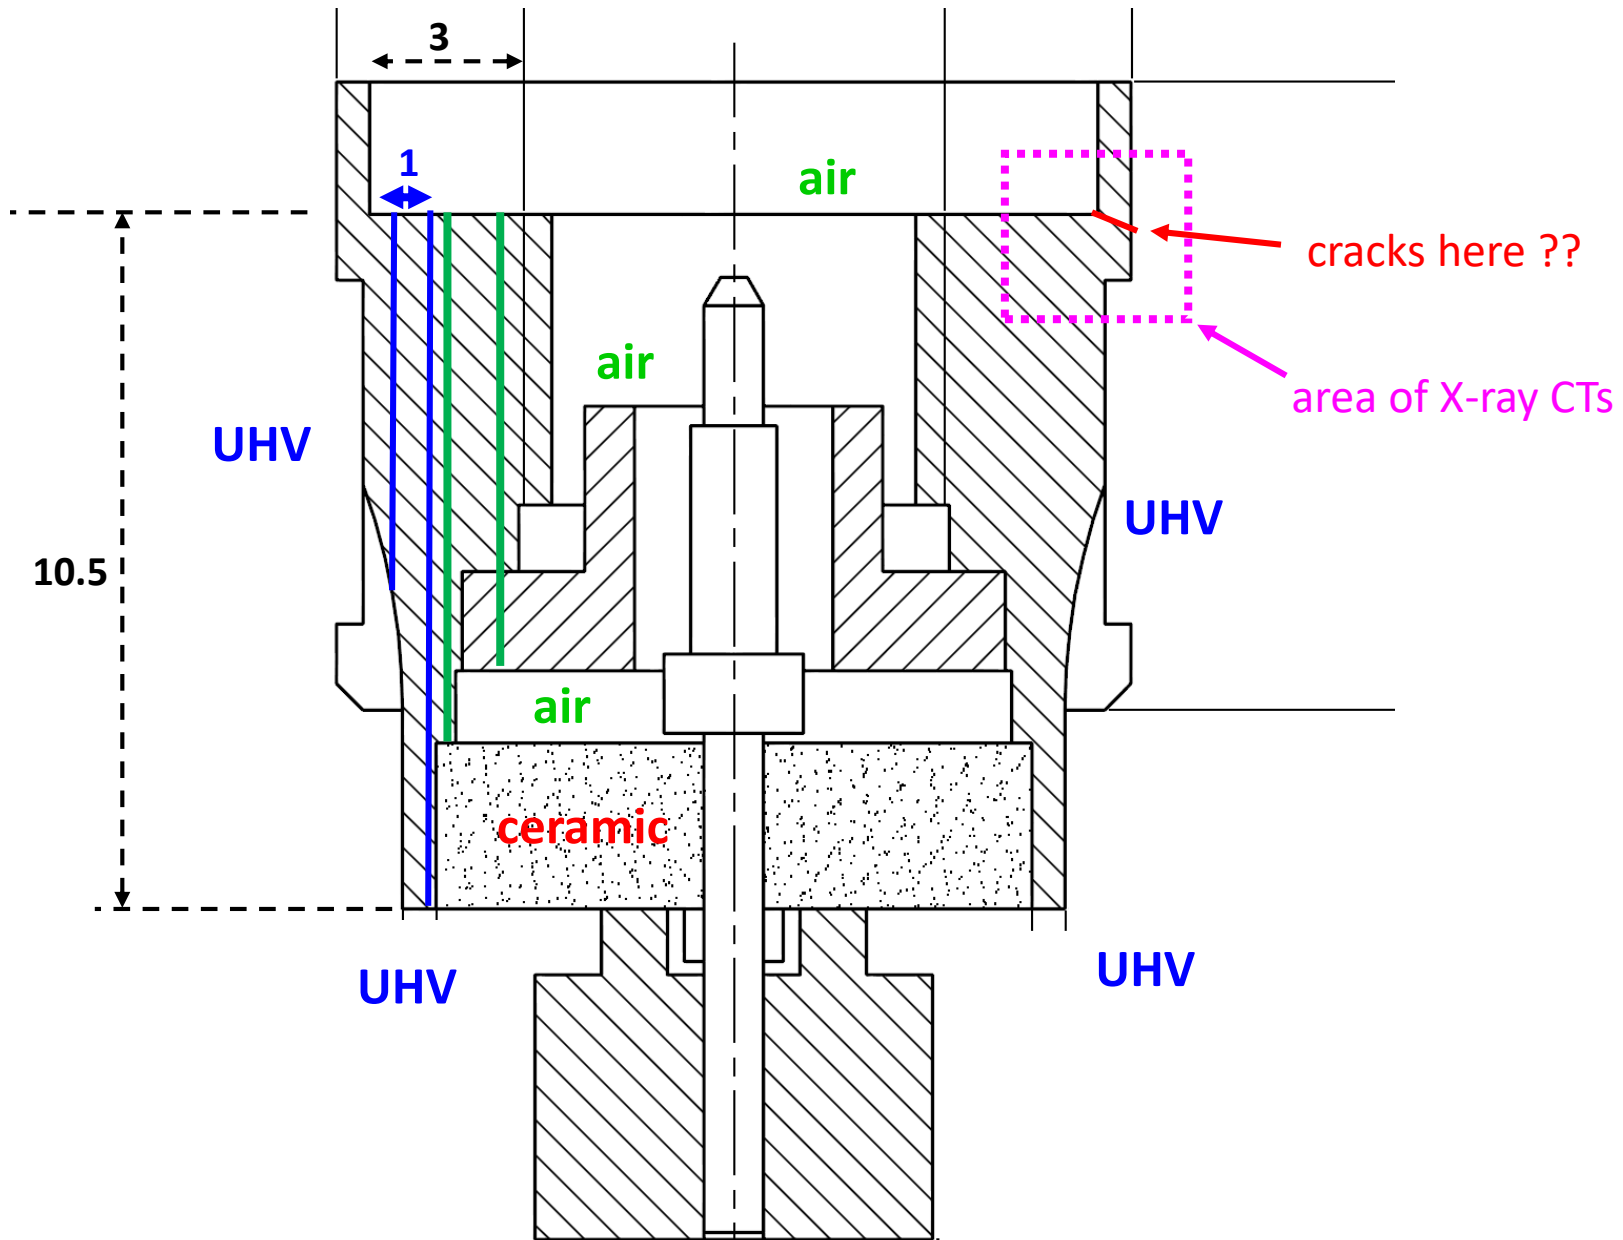
if bulk defects (vertical channels/lines) are responsible for UHV leaks then only the **blue lines** can, NOT the **green lines** (not connecting with UHV)

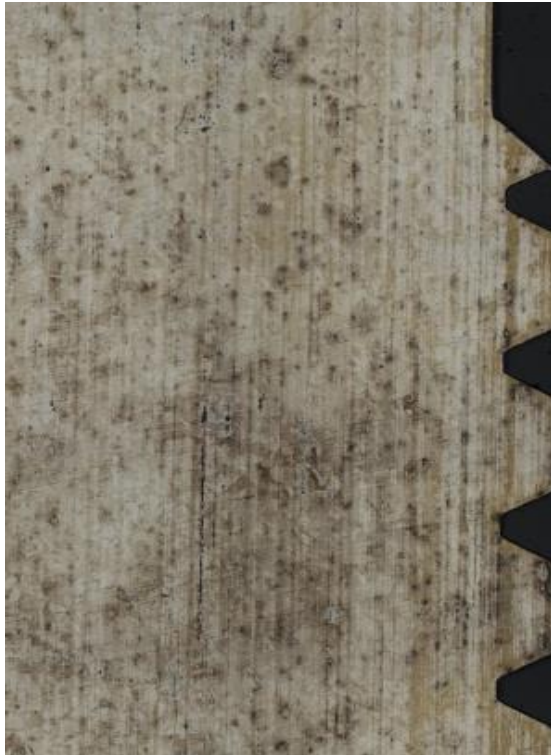
ZOOM
*many vertical channels
can be seen now ...*

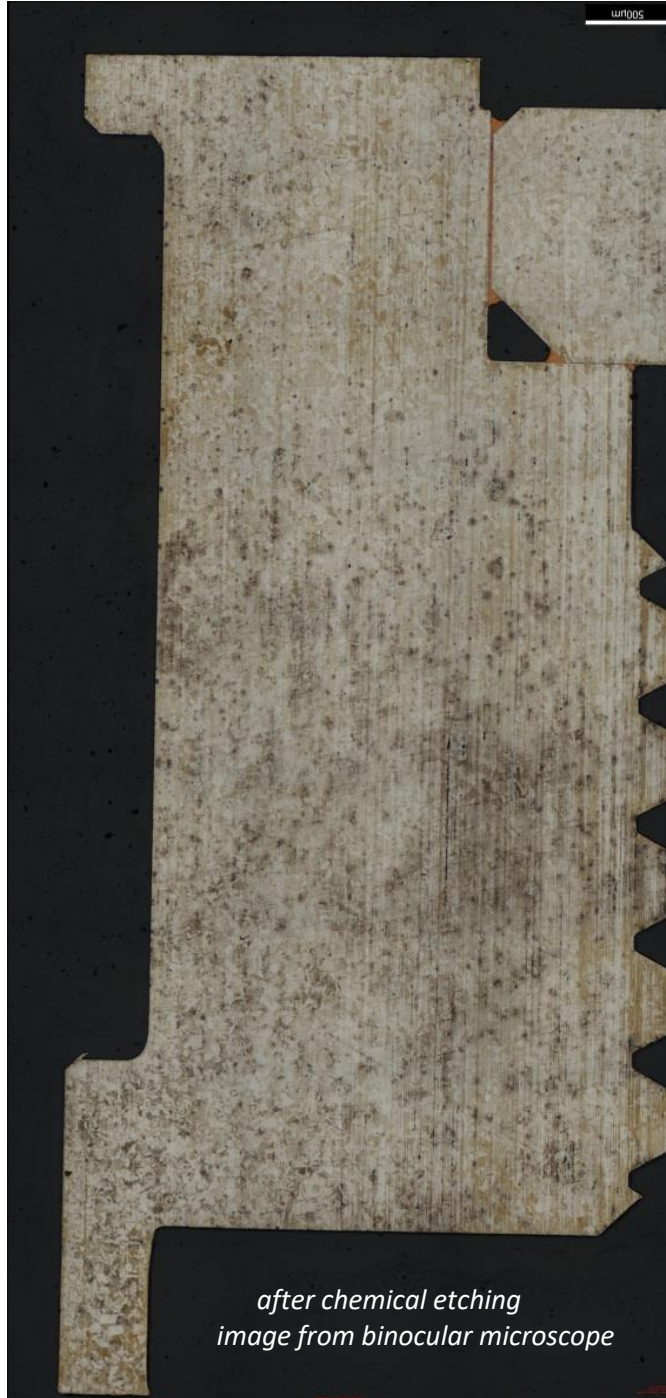
*after chemical etching
image from binocular microscope*

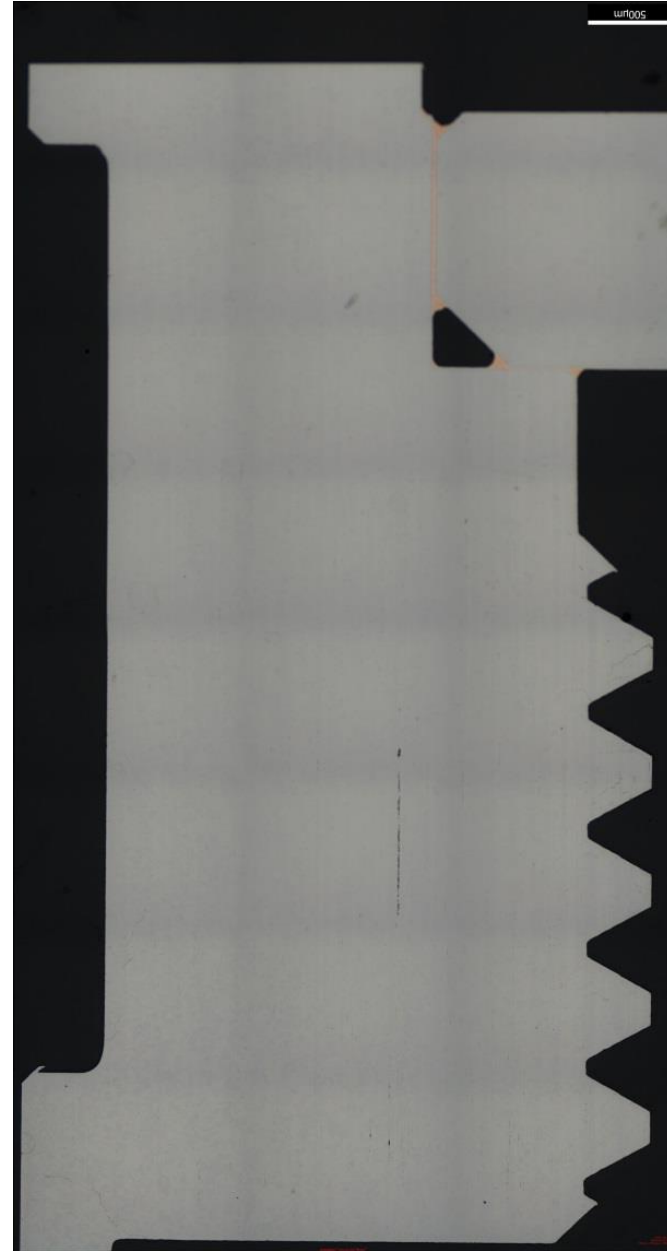
*before chemical etching,
image from binocular microscope*

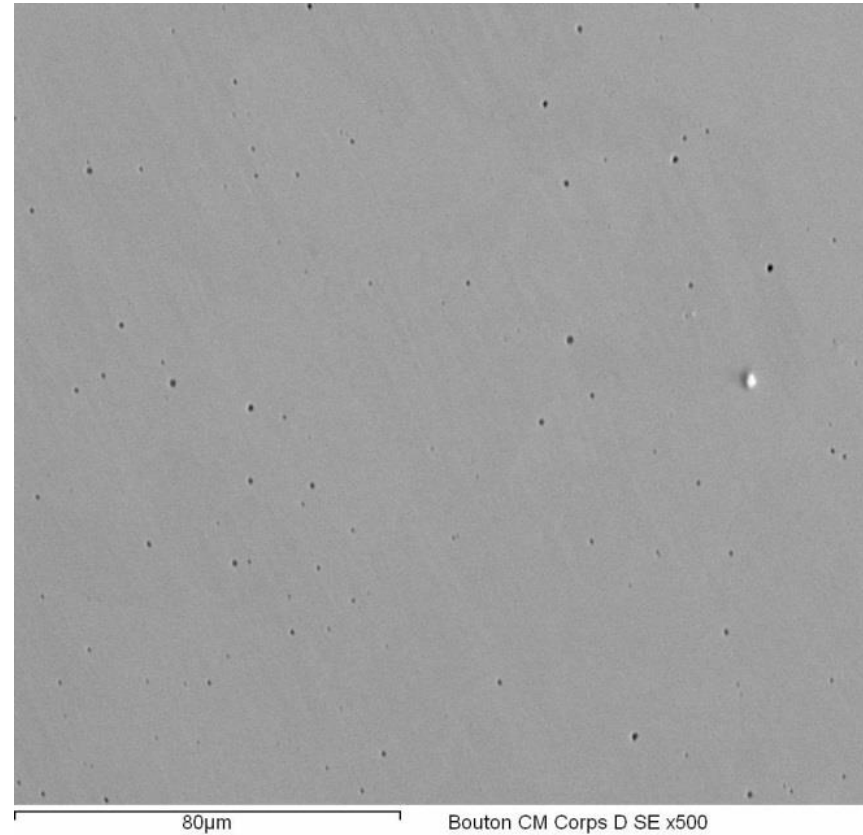
*transverse cut in BPM-body
image from electron-beam-microscope
before chemical etching
many holes observable ...
all are less than 2 μm diameter ...*

26 10 2017 JM *how many of them are channels ... ???*

the very unfortunate occurrence of ultra-small channels in our BPMs outer-body is due to the combination of :

- gaseous impurities (bubbles, inclusions) presence in the bulk**
- technique of extruding into bars or rods (not into slabs)**
- absence of any UHV remelting technique**

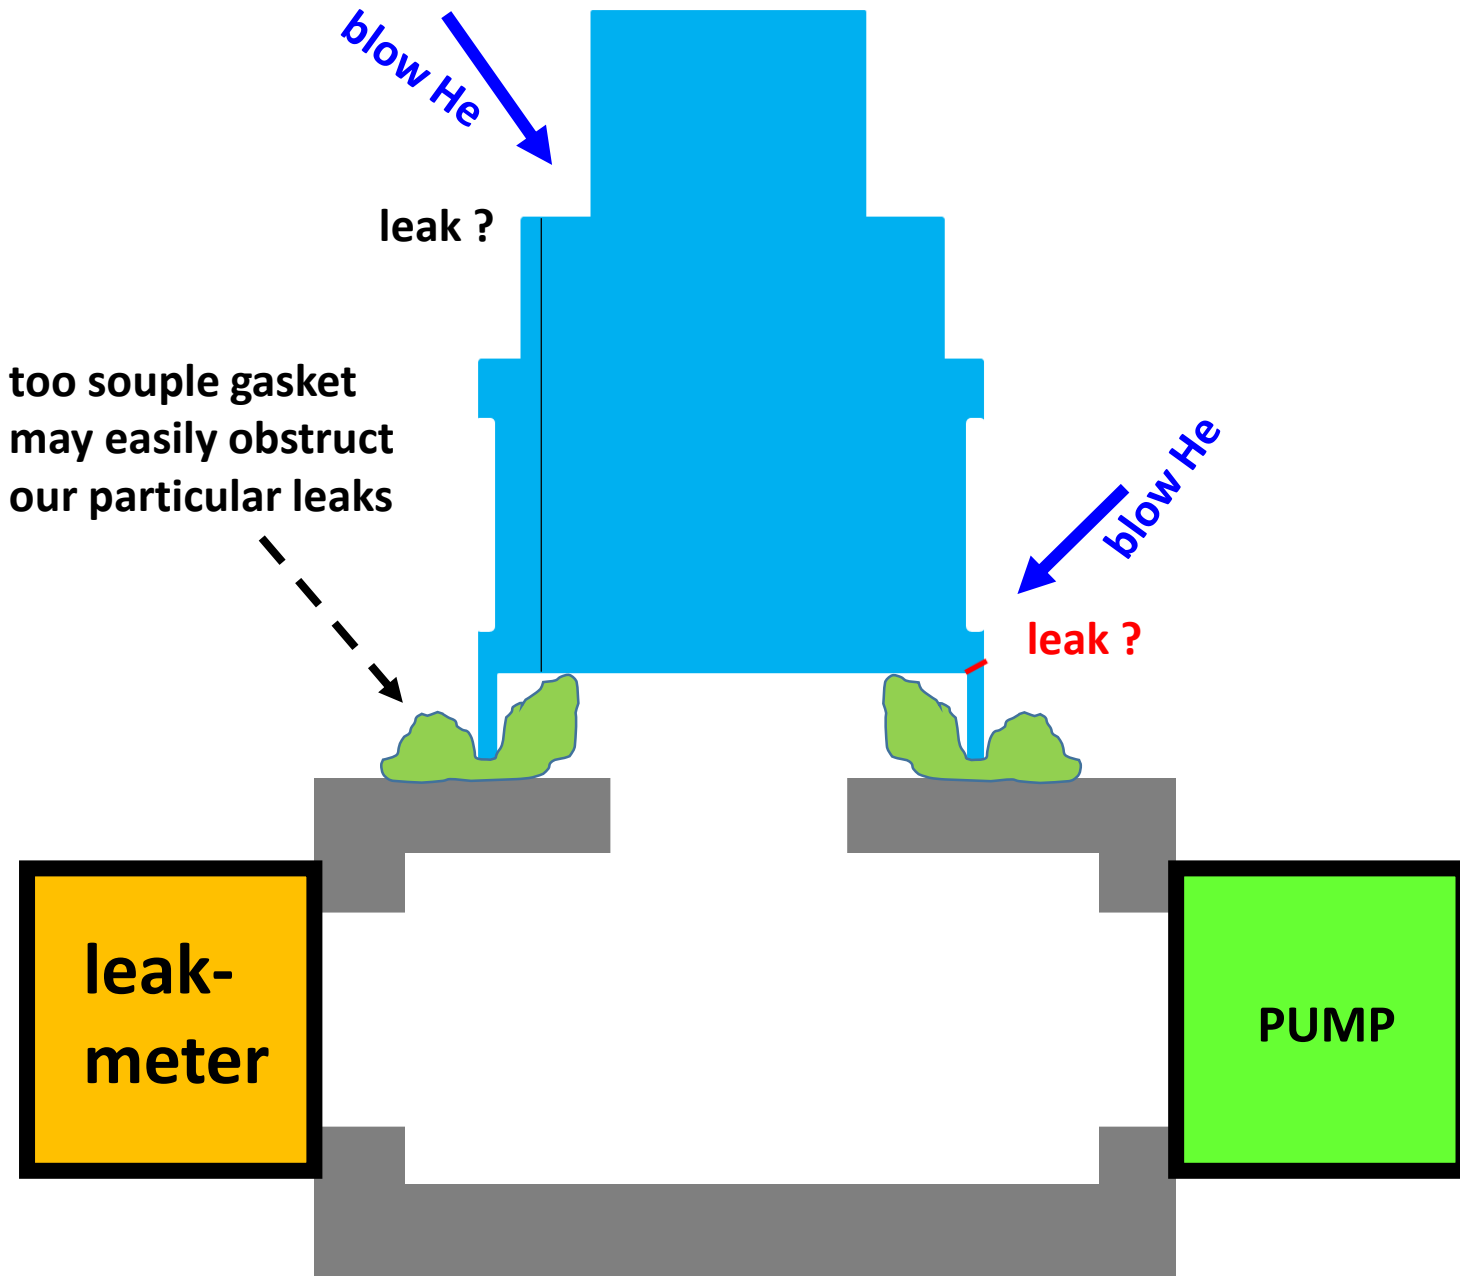
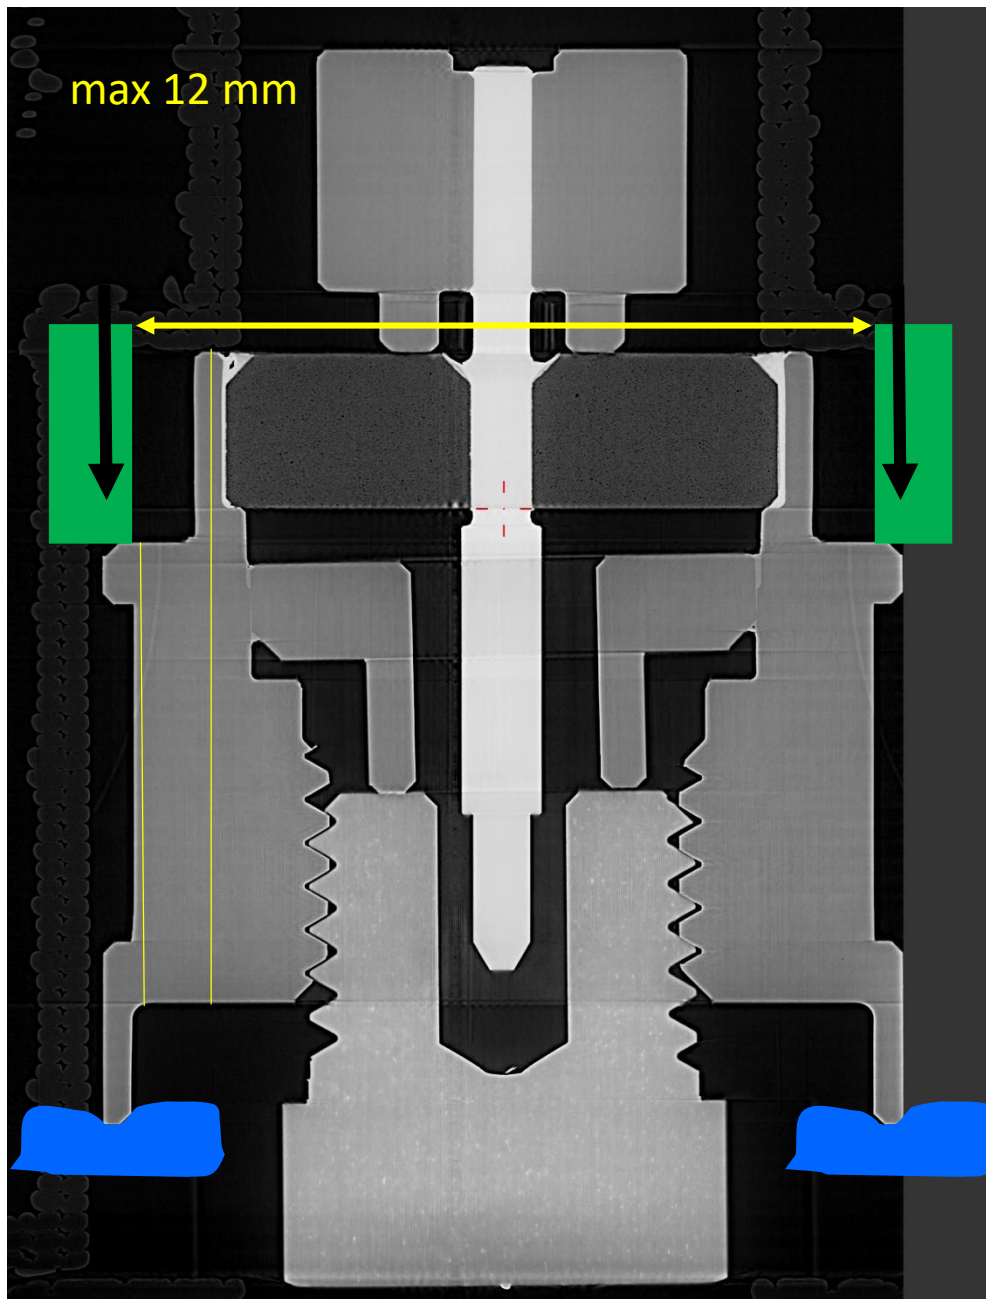
in Yellow : the possible leaking channels

in Green : the ring that presses the BPM downwards

in Blue : the gasket

in Red : surface where the channels can reach UHV

**final solution : configure a specific leak-test, obviously non-destructive
down to 1E-10 (mbar litre / sec) sensitivity
that is practically feasible and reliable
to really sort-out these bad units**

done by colleagues in
ESRF Front-End group,
with success !!

on about 700units
10min/unit

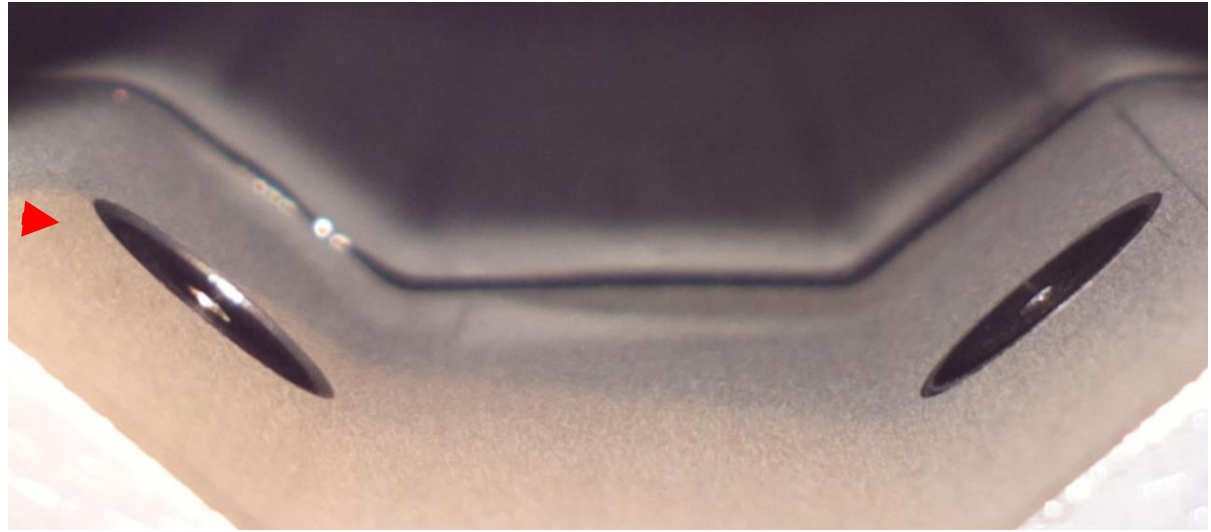
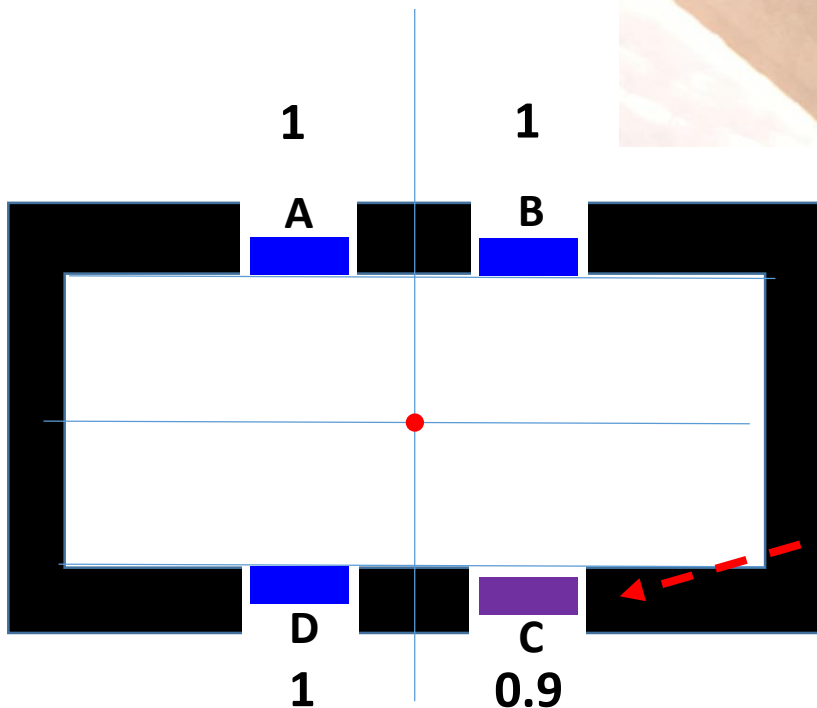
retracted
button
on chamber "0413"

electric offset BPM-block :
non-equal sensitivity of the 4 buttons
due to non-equal positioning

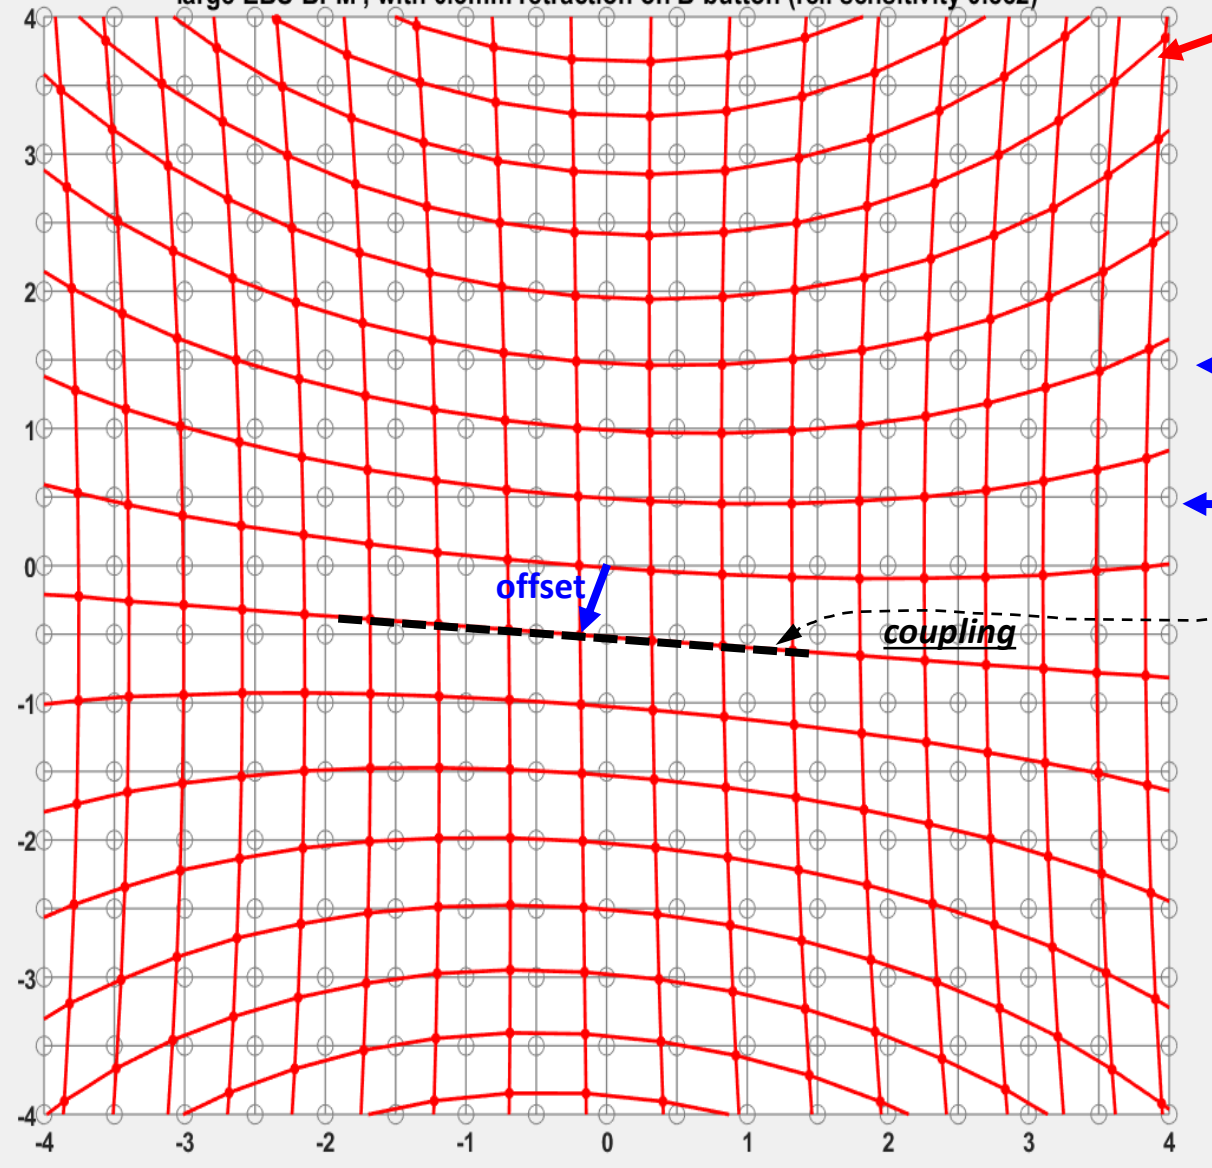
large EBS-BPM , with 0.3mm retraction on B-button (rel. sensitivity 0.882)

for one button = 0.3mm retracted with relative sensitivity of 0.882 i.e. -1.1dB

H-to-V=79mrad
V-to-H=13mrad

conclusion : the resulting **offset** is a minor, manageable effect (after beam-based alignment) but the **coupling** is much stronger affected, and can **not** be corrected (by beam-based alignment) but only (be reduced) by measuring it & compensating it
