**experience with UHV-leaks on 1500 units of
BPM-buttons at the ESRF in 2016**

***Kees Scheidt, ESRF,
ASD, diagnostics group***

contents

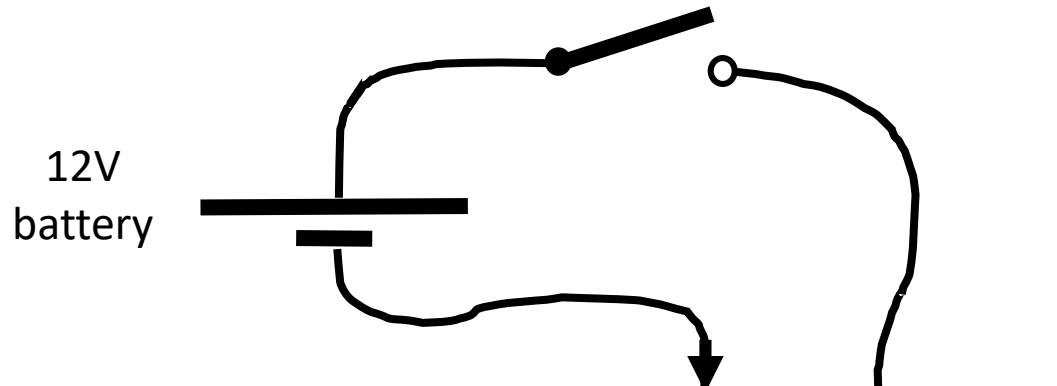
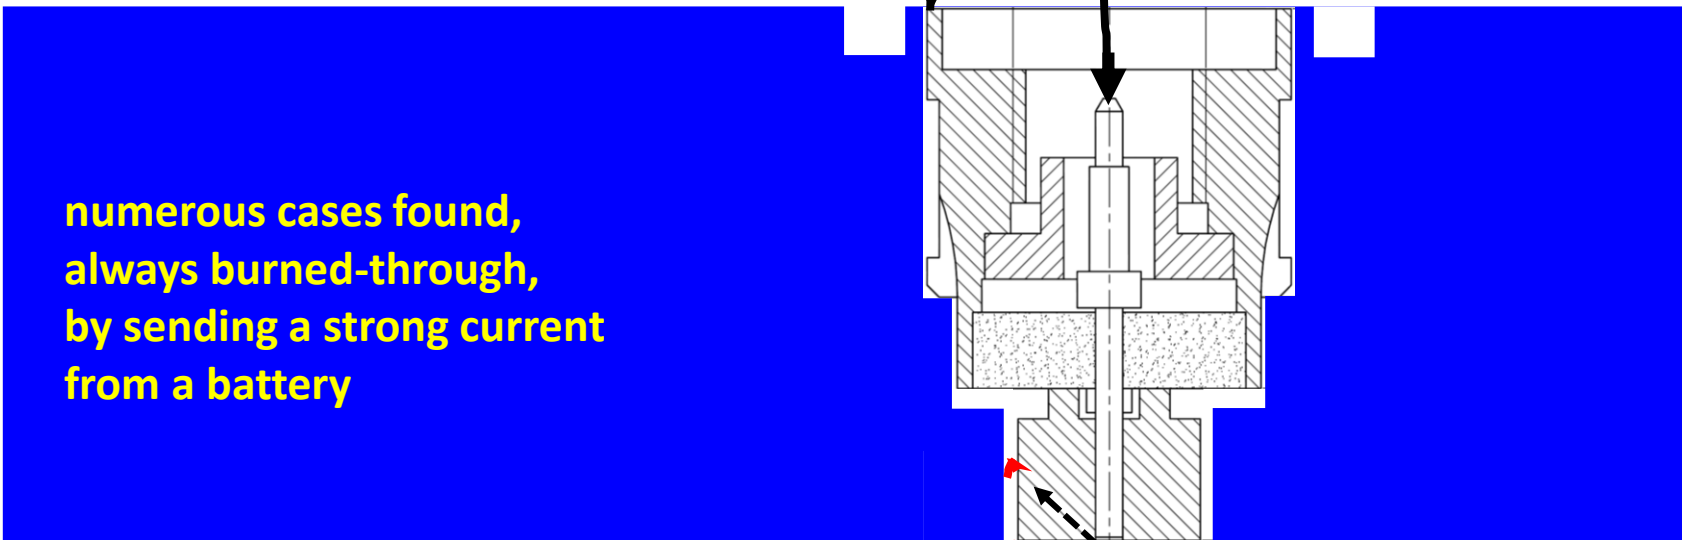
problems of dust, particles, slivers, foils ? ... INSIDE the vacuum chamber causing NON Hi-Z impedance of the button ...

numerous cases found,
always burned-through,
by sending a strong current
from a battery

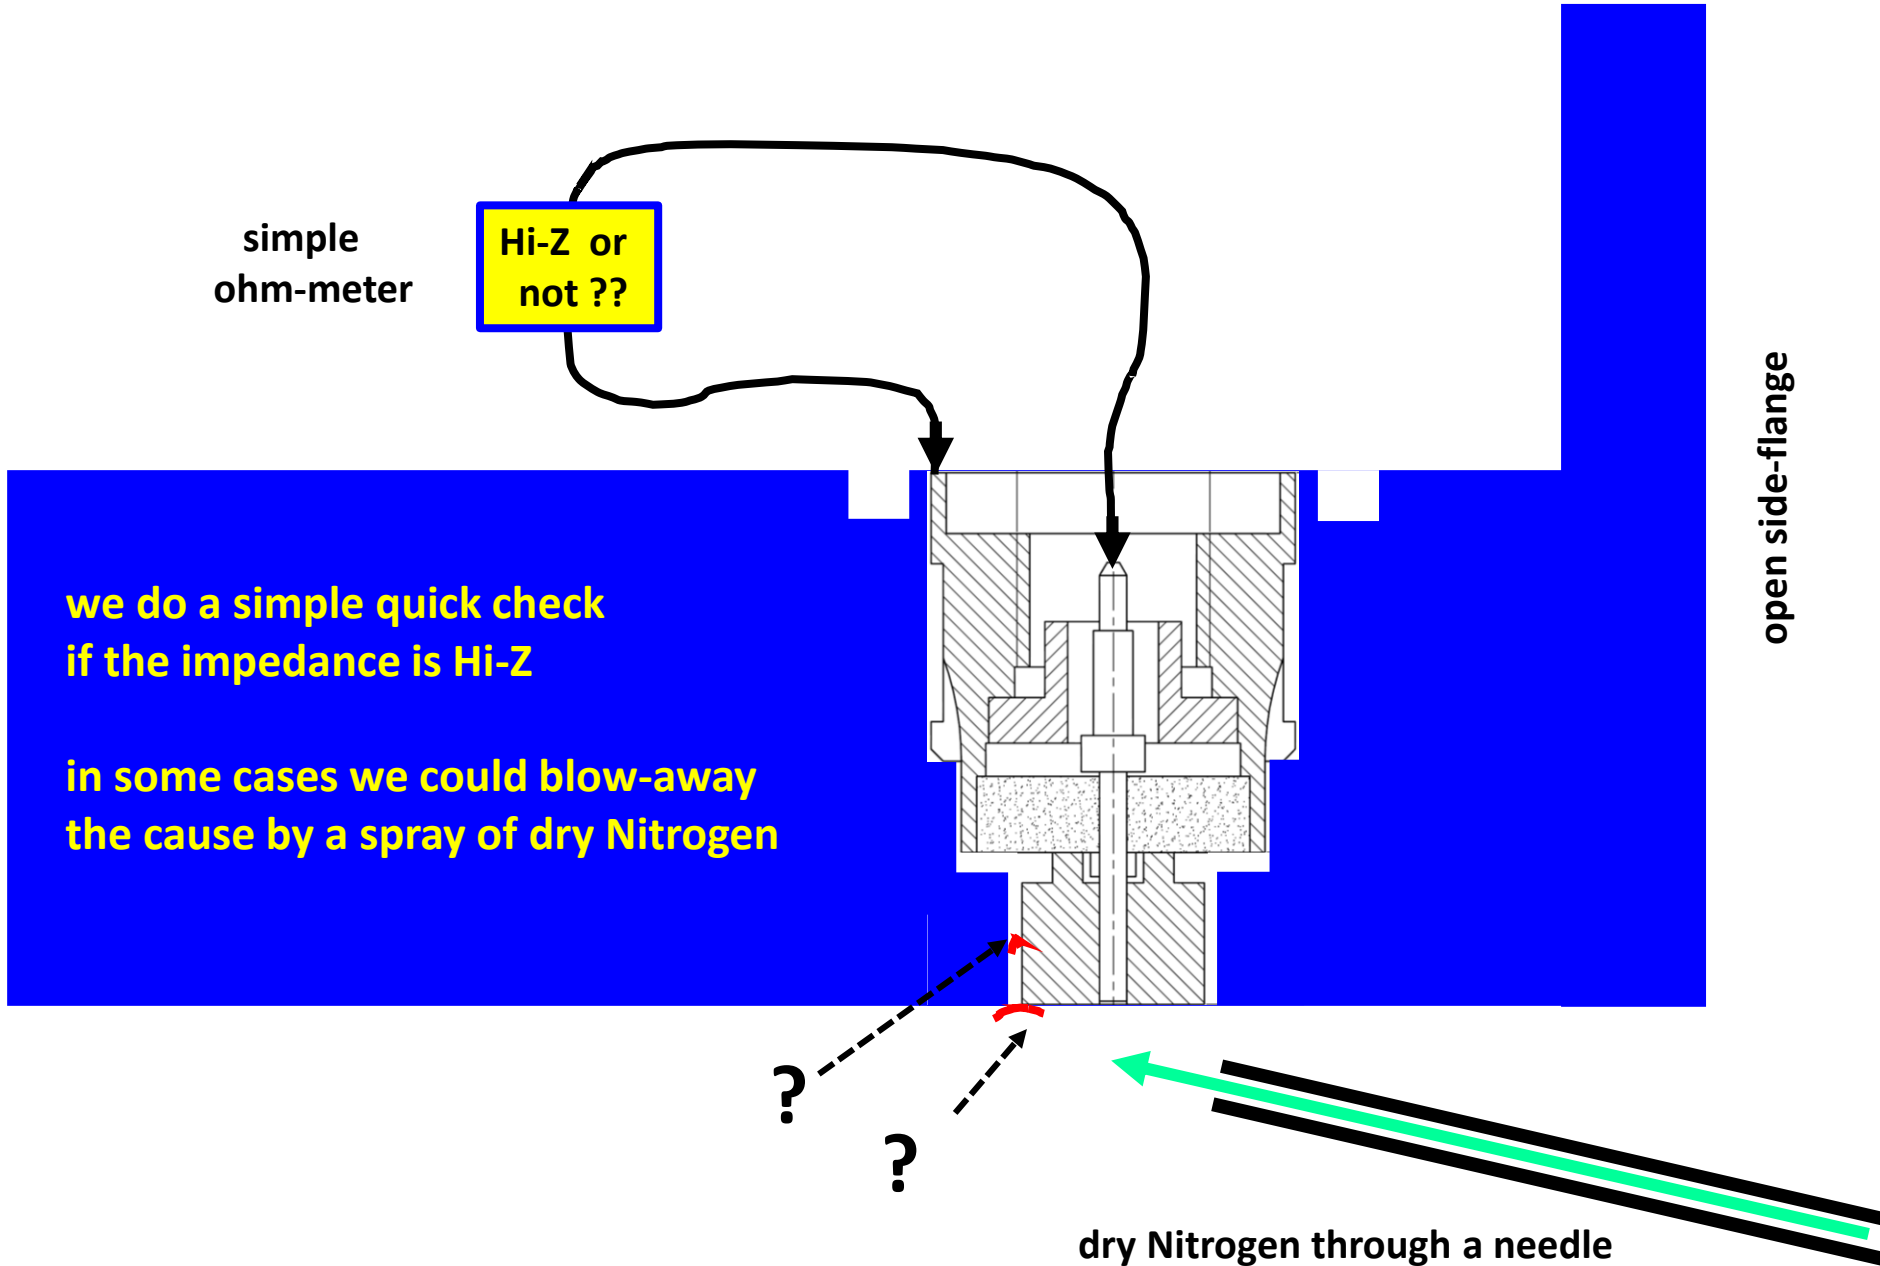
problems of dust, particles, slivers, foils ?
... INSIDE the vacuum chamber

in some cases we could blow-away
the cause by a spray of dry Nitrogen

dry Nitrogen through a needle

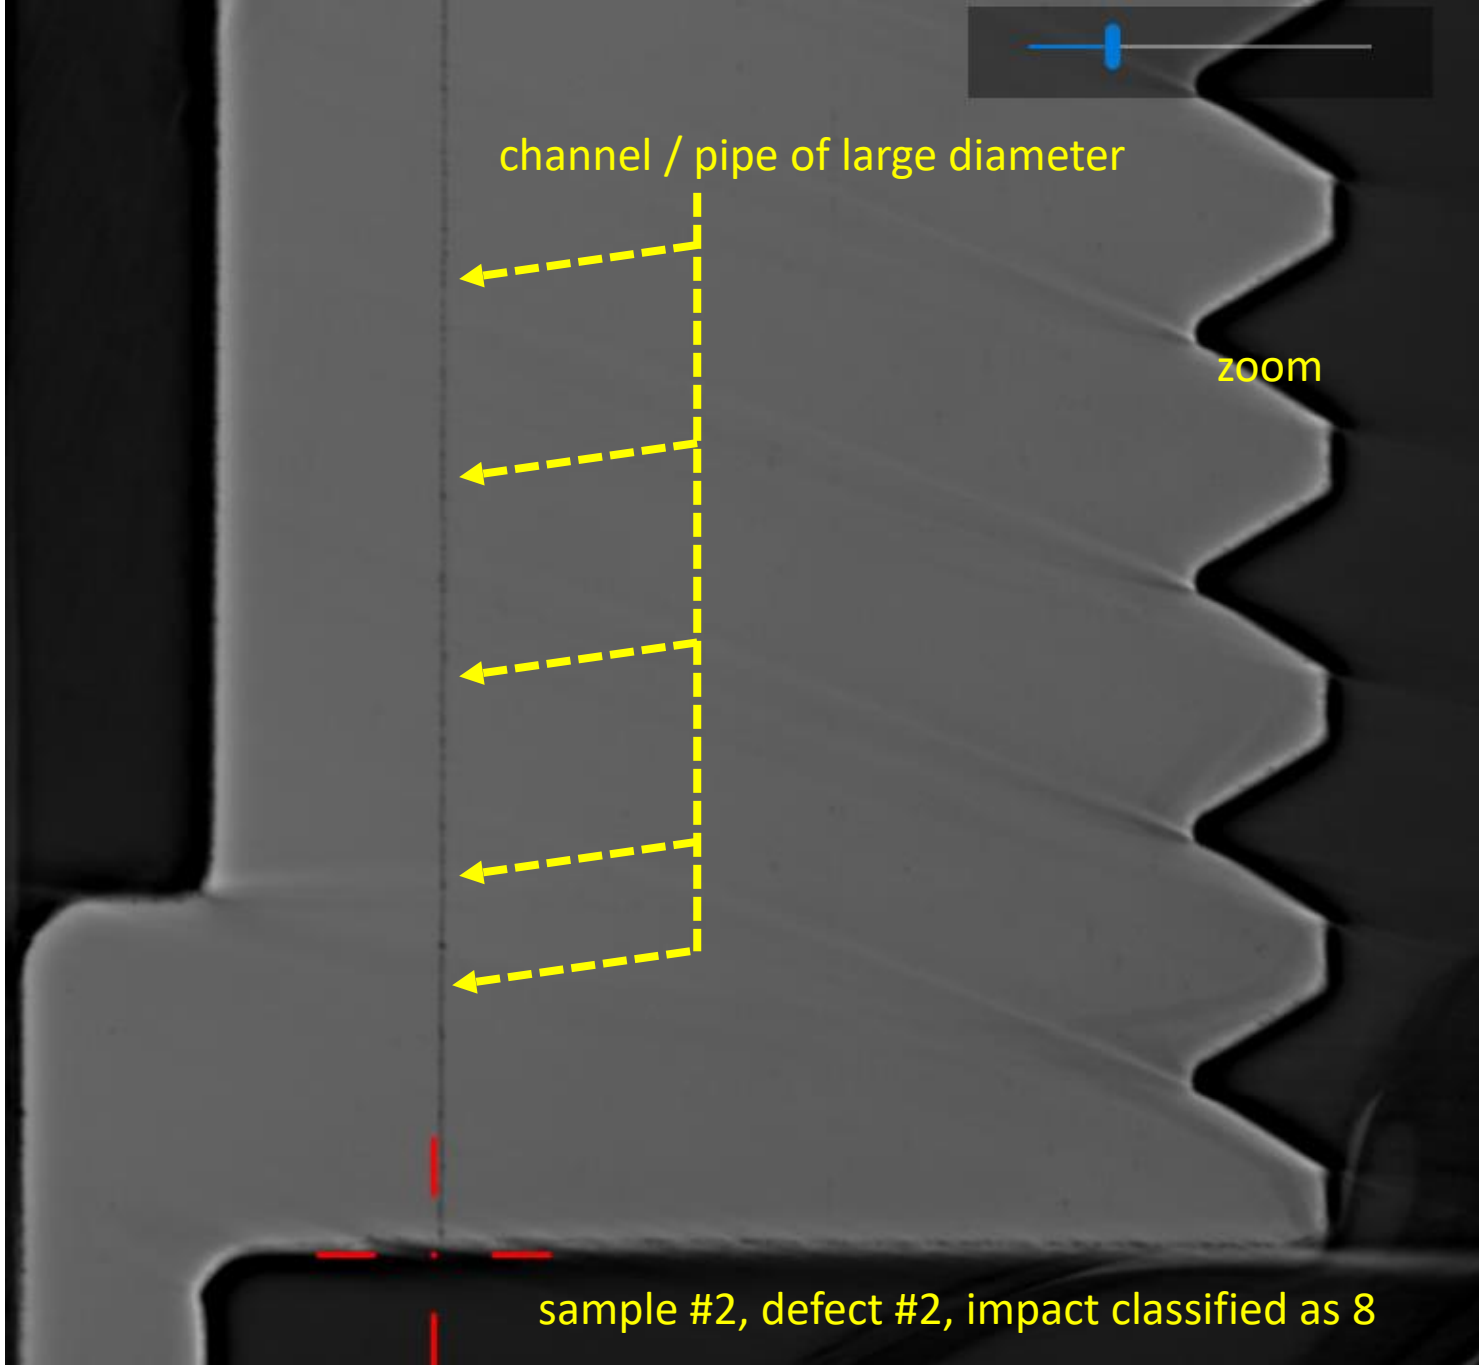
sample #2, defect #2, impact classified as 8
