**experience with UHV-leaks on 1500 units of
BPM-buttons at the ESRF in 2016**

***Kees Scheidt, ESRF,
ASD, diagnostics group***

contents

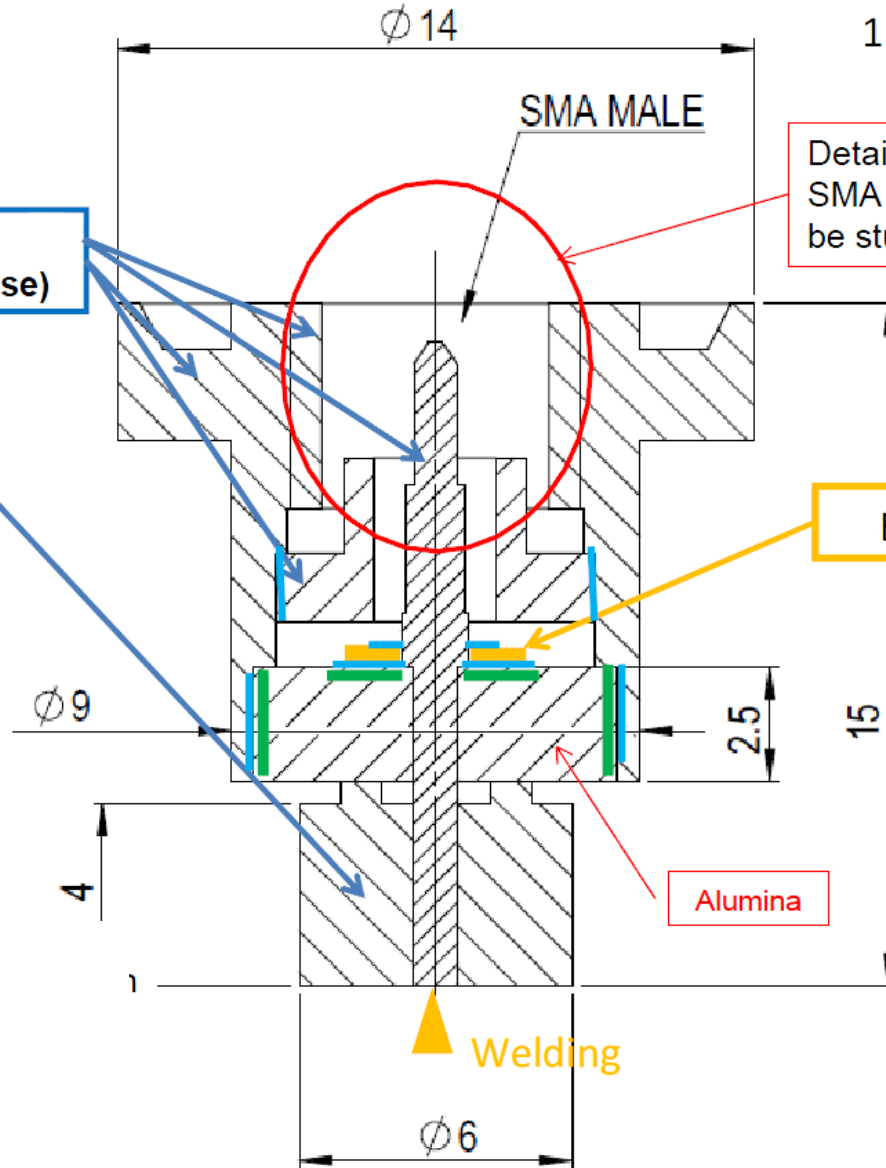
Brazing technology NOT the same with Kyocera :

we did not like
this Cu brim ... !

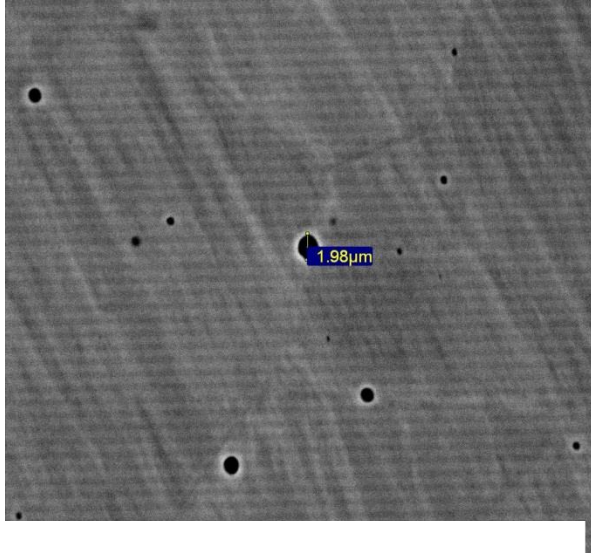
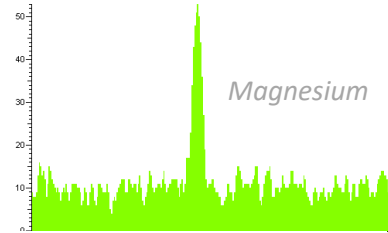
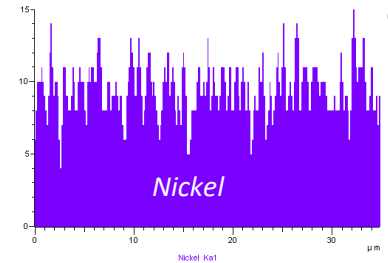
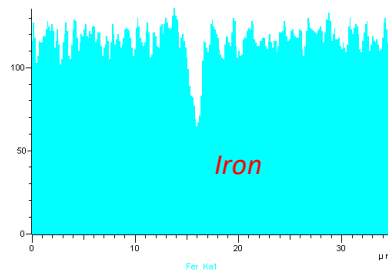
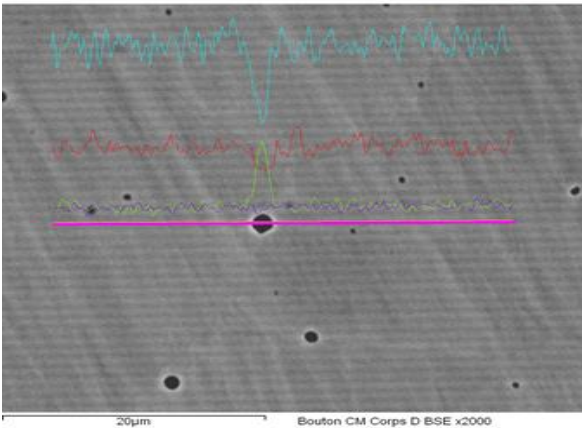
Bouton CM –Bride Coupe transv Observation MEB ech non attaqué chim

40 μm

*transverse cut in BPM-body
image from electron-beam-microscope
before chemical etching
many holes observable ...
all are less than 2 μm diameter ...*

26 10 2017 JM *how many of them are channels ... ???*

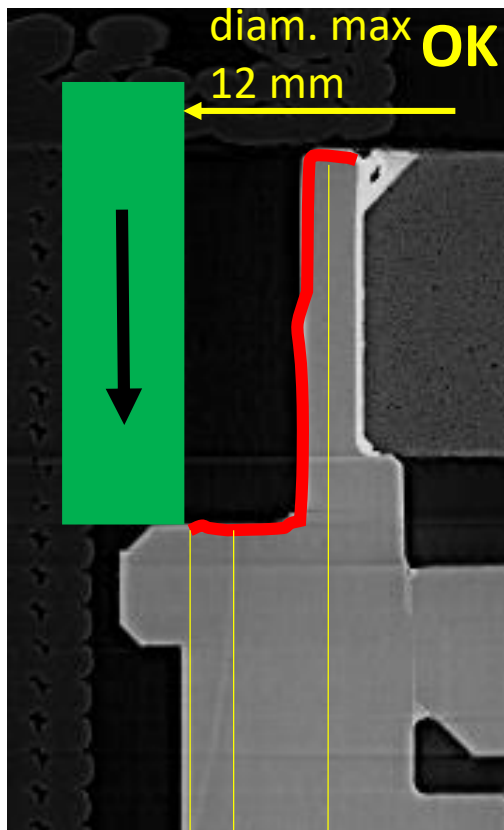
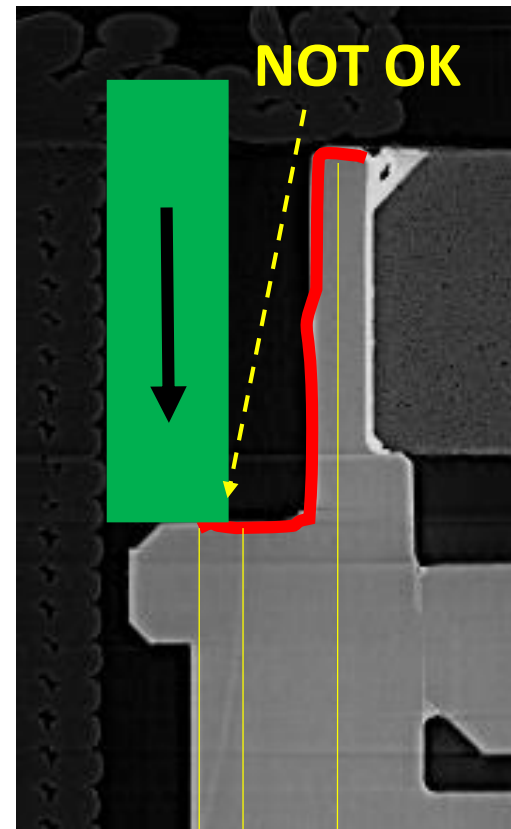
in Yellow : the possible leaking channels

in Red : surface where the channels can reach UHV

in Green : the ring that presses the BPM downwards

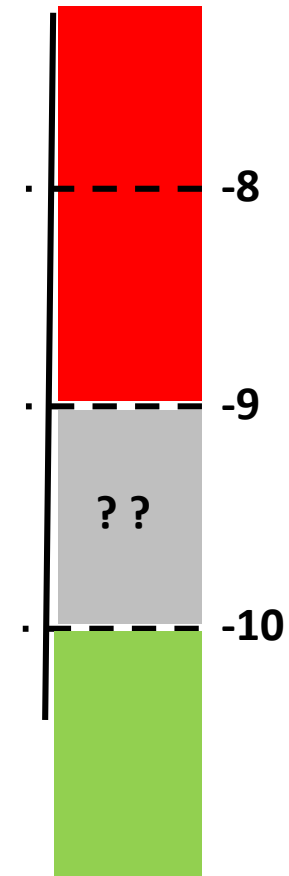
we had chambers rejected after leak-test on the final FAT
of only **2 E-10 mbar litre / sec**

**ideally : BPM-button manufacturer should extent the quality
of their leak-tests by 1 magnitude, down to 1 E-10**

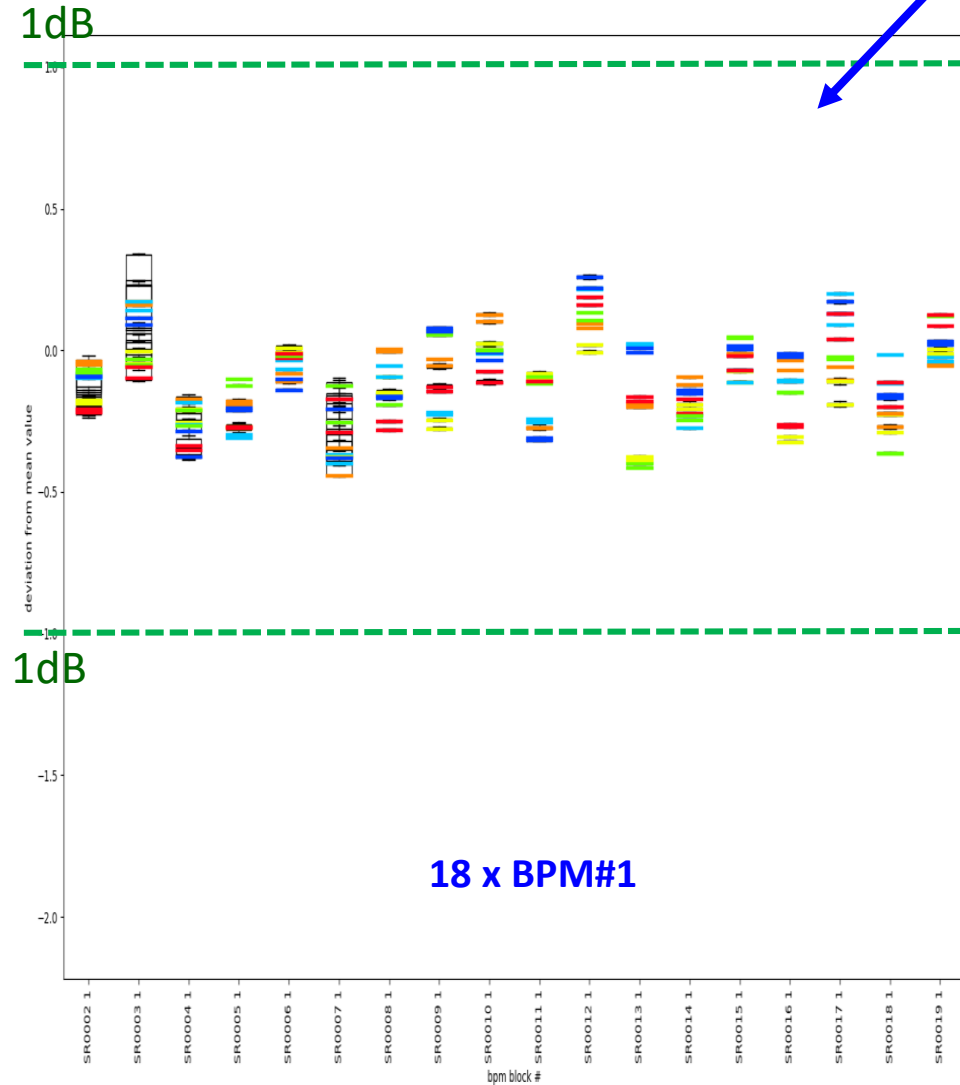
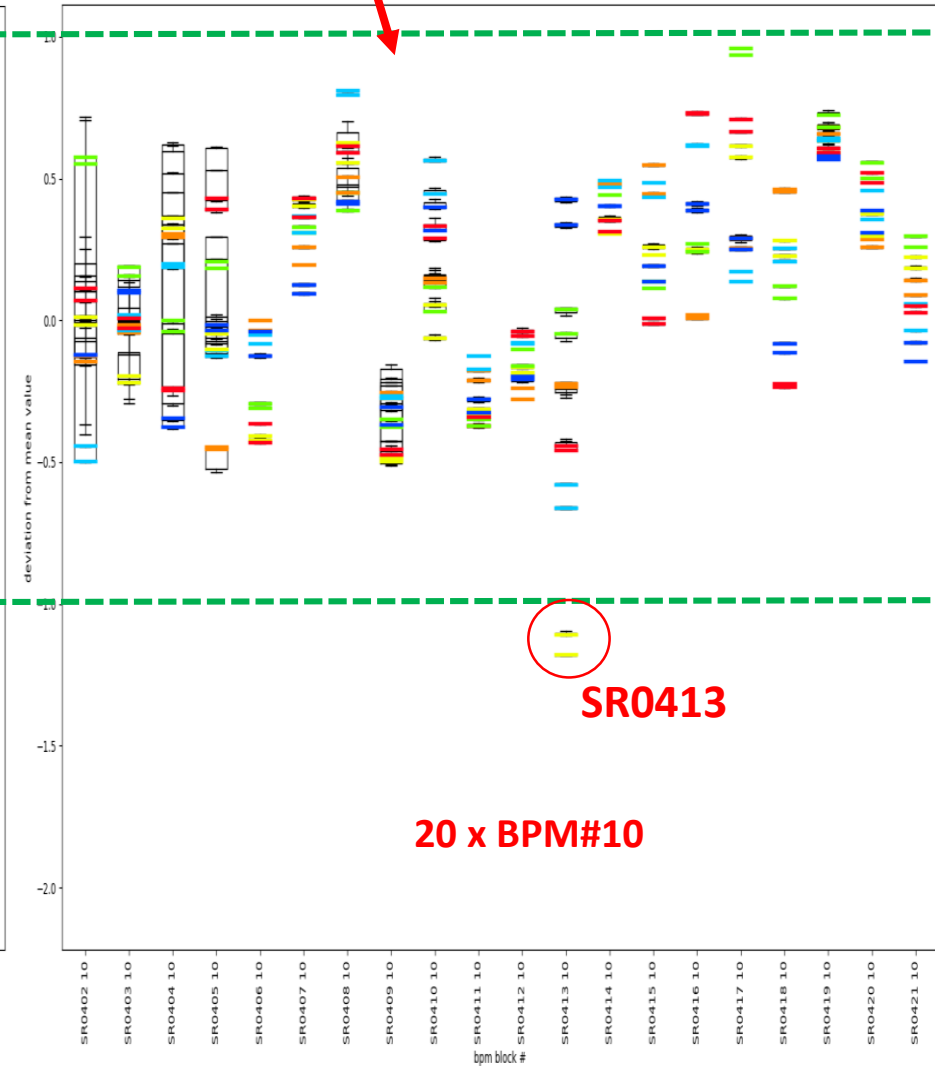
results of RF-cross-transmission measurements on numerous EBS-BPMs,
here below only of **BPM #1** and **BPM #10**

manufacturer : FMB Berlin,
Ch#1=BPM#1

manufacturer : PINK Germany,
Ch#14=BPM#10

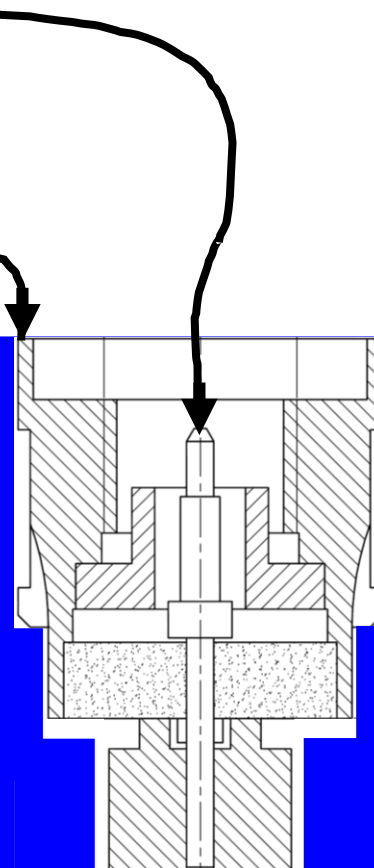
problems of dust, particles, slivers, foils ? ... INSIDE the vacuum chamber
causing NON Hi-Z impedance of the button ...
unpredictable & unexplainable occurrences in our new chambers
both on *upper-side* and on *lower-side* Buttons

Hi-Z or
not ??

we do a simple quick check
if the impedance is Hi-Z

numerous cases found,
always burned-through,
by sending a strong current
from a battery

in some cases we could blow-away
the cause by a spray of dry Nitrogen

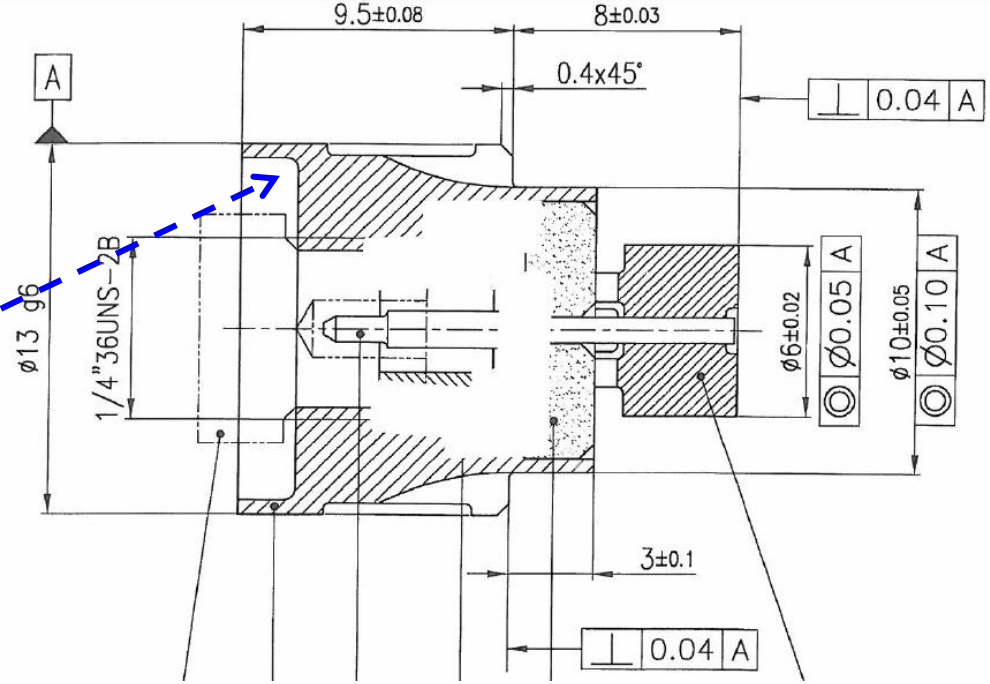
DLS

rounded corners

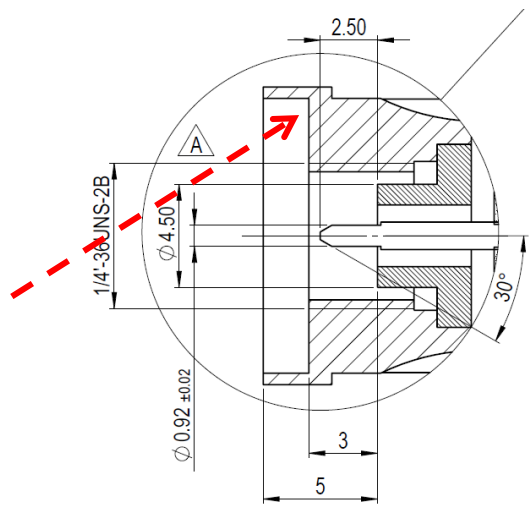
ESRF

sharp corners

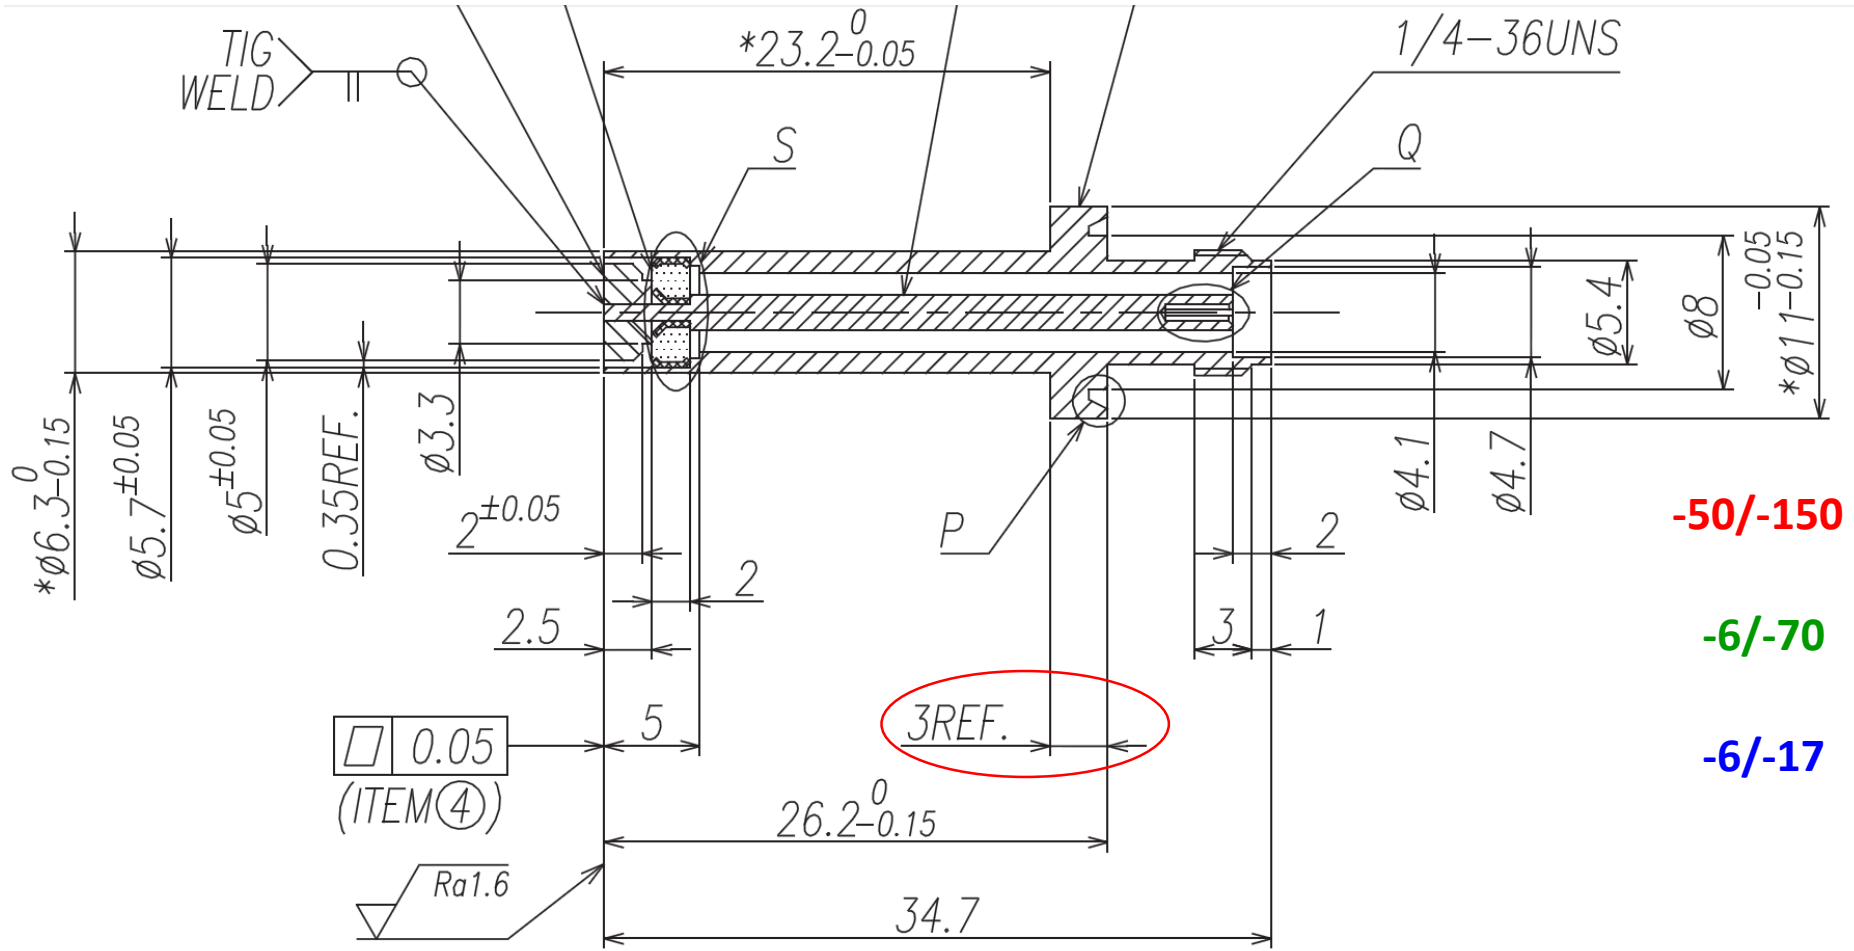
BPM button made for MAX-4 by Kyocera,

**Large dimensional tolerances : e.g. -50/-150um
 no tolerances of concentricity (less important with encapsulated button)**

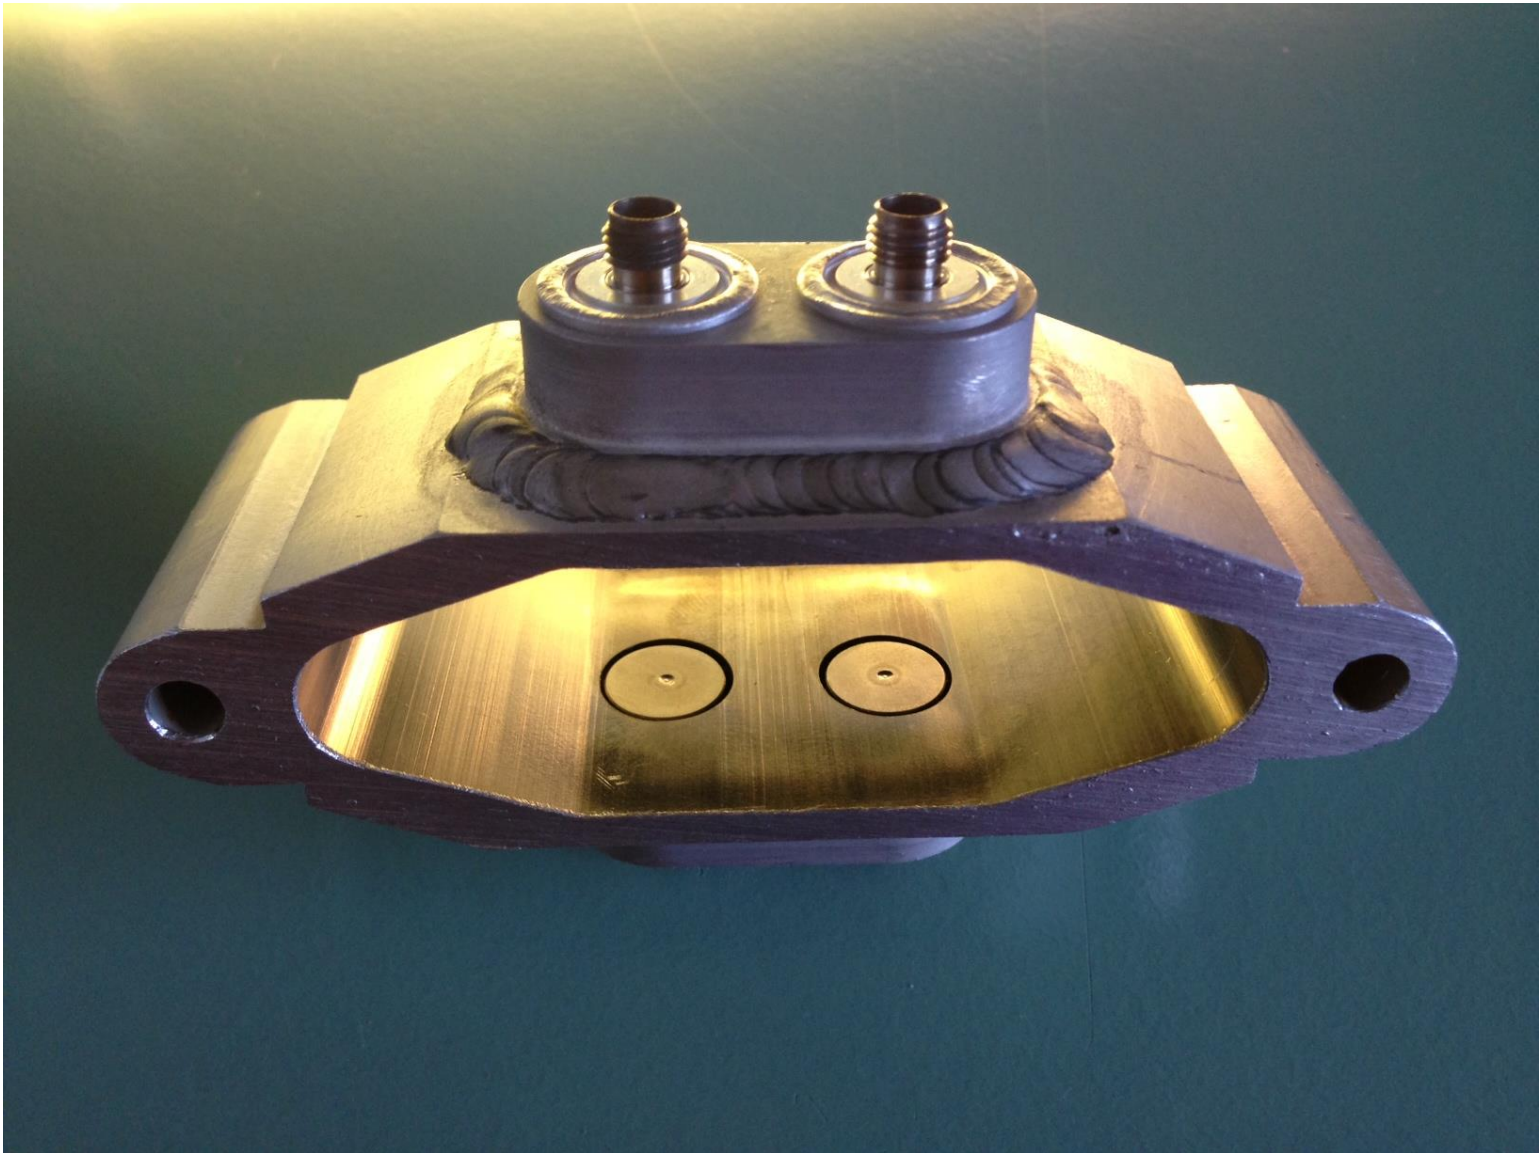
Titanium does not look
like a suitable material,

- Radiation damage to surface
- Poor elasticity
