CASE STUDY

Environmental impact of the Mount Polley mine disaster

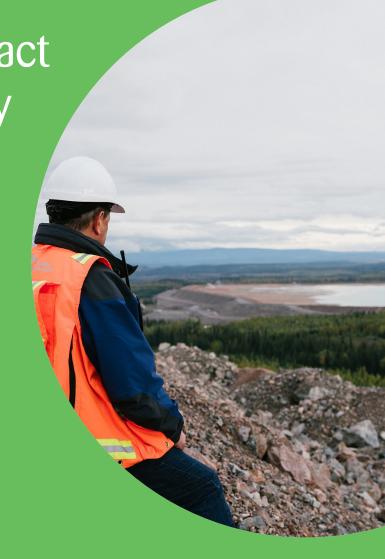
On 4th August 2014 the Mount Polley mine tailings dam failed, resulting in 25 million m³ of material discharged into the surrounding area, the second largest failure by volume on record.

* Aerial images courtesy of NASA Earth Observatory
